## Lessons learned from the past earthquakes on building performance in Turkey

Barbaros Atmaca\*<sup>ID</sup>, Serhat Demir<sup>ID</sup>, Murat Günaydın<sup>ID</sup>, Ahmet Can Altunışık<sup>ID</sup>

*Karadeniz Technical University, Department of Civil Engineering, Trabzon, Turkey*

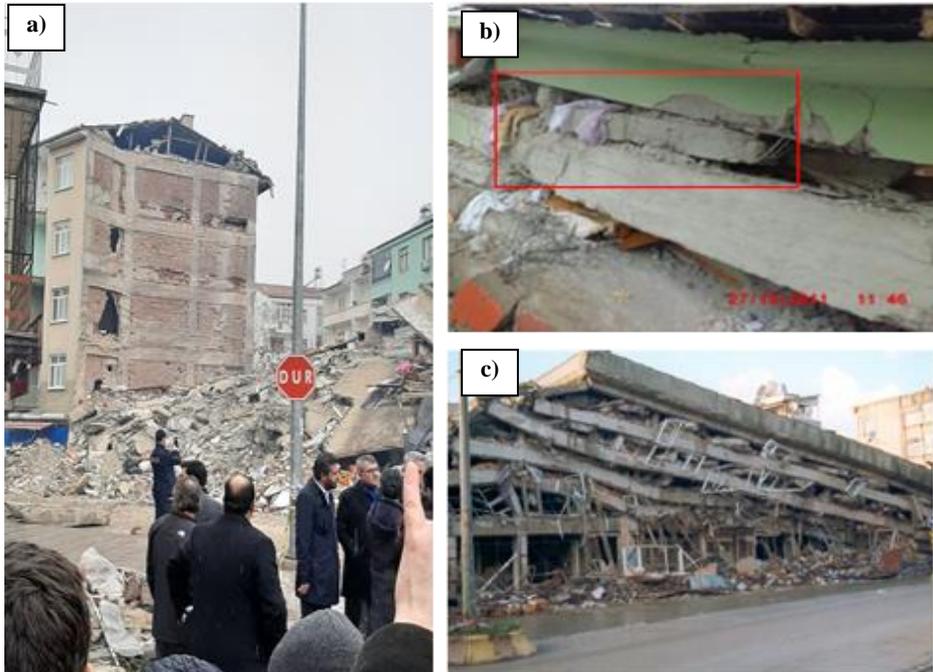
The experience taken from the past earthquakes is showed that the reason of the most damages or collapses of RC frame buildings is strong beam-weak column mechanism. In this mechanism, plastic hinge occurs on weaker columns, and this event causes unwanted brittle collapsed. But, it is desirable that plastic hinge should be formed in beams rather than columns, thus preventing of brittle collapse. The collapses and damages caused by this mechanism in past earthquakes are shown in Fig. 6. In light of experiences from past earthquakes, strong column-weak beam concept was included in the TEC 1998 and more stringent detailing requirements were defined for high ductility systems.

**Fig. 6.** Strong beam-weak columns damages observed after (a) Elazığ-Sivrice, (b) Van [21] and (c) Kocaeli [17] earthquakes

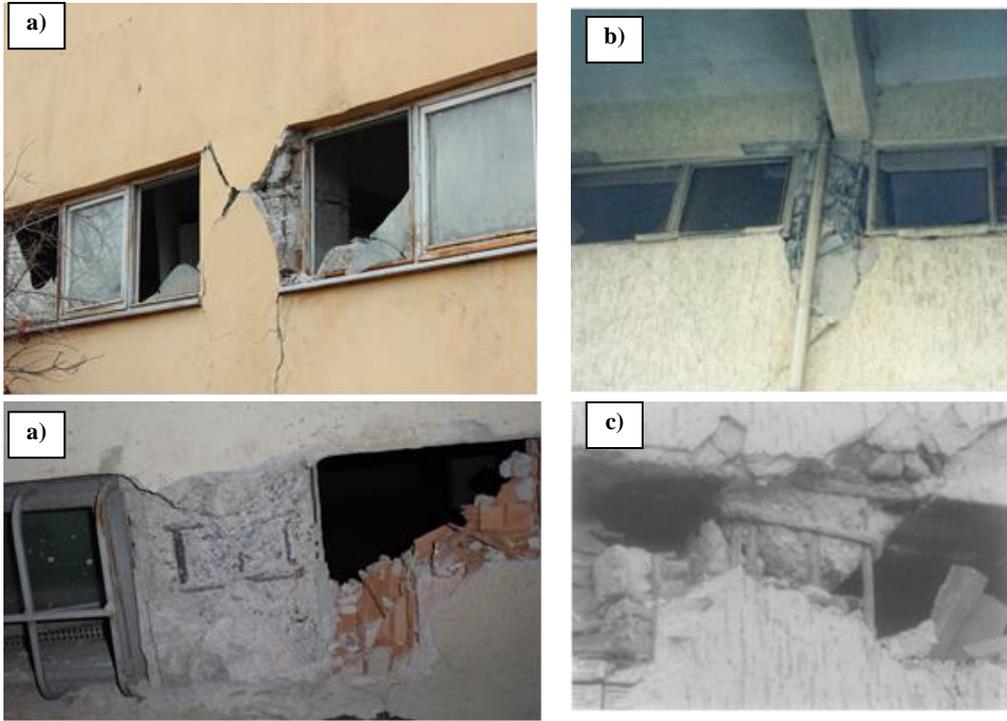
Horizontal forces acting on the structure at the floor level during the earthquake are transferred from slabs and beams to columns. These forces cause to be formed bending moments and shear forces into the columns. On account of the arrangement of non-structural and structural elements such as infill walls with opening and columns, short columns may occur. This causes the column length to be shortened. The shortening of the column length causes the bending moments and shear forces to increase. Past earthquakes showed that short column effect has caused many RC buildings to damage or collapse (Fig. 7)

**Fig. 7.** Short column based damages observed after (a) Elazığ-Sivrice, (b) Kocaeli [17] and (c) Bingöl [15] earthquakes

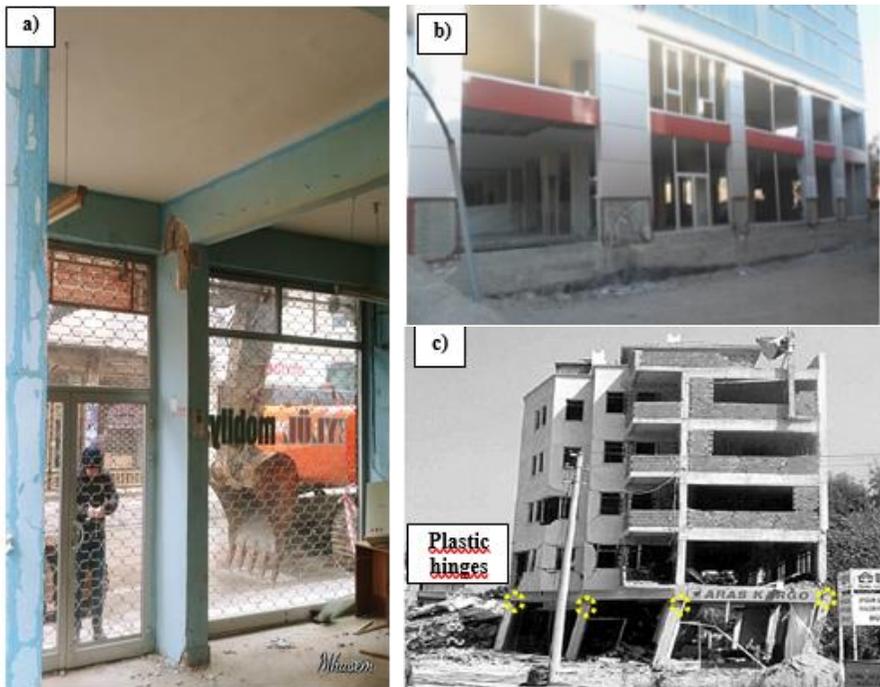
Especially the first floors of many buildings on the main street are used as a commercial area such as shops or showrooms. More than one side of these commercial floors is covered with windows and the second floor is generally closed with infill walls so soft storey problem occurred. In buildings with soft floors, plastic hinges occur in columns and this event causes unwanted brittle collapsed (Fig. 8).

**Fig. 8.** Soft storey damages observed after (a) Elazığ-Sivrice, (b) Van [19] and (c) Kocaeli [13] earthquakes

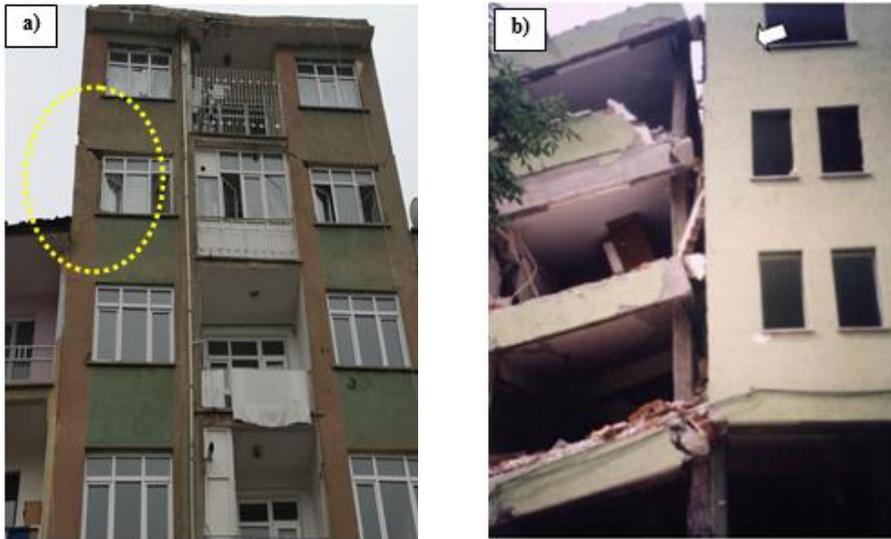
During the earthquake, there must be a sufficient distance between neighboring buildings so that the buildings can move freely and do not have hammering. When the floor levels of the buildings are not equal, they suffer much damage. Although there is a restriction in the the TEC about the minimum safe distance between the adjacent buildings, a significant portion of the building stock in Turkey was built as adjacent. In this case, although the building is not damaged by the earthquake, it increases the probability of damage due to the impact of the neighboring building. The collapses and damages caused by hammering effects in past earthquakes are shown in Fig. 9.

**Fig. 9.** Observed hammering effects (a) Elazığ-Sivrice and (b) Bingöl [14] earthquakes

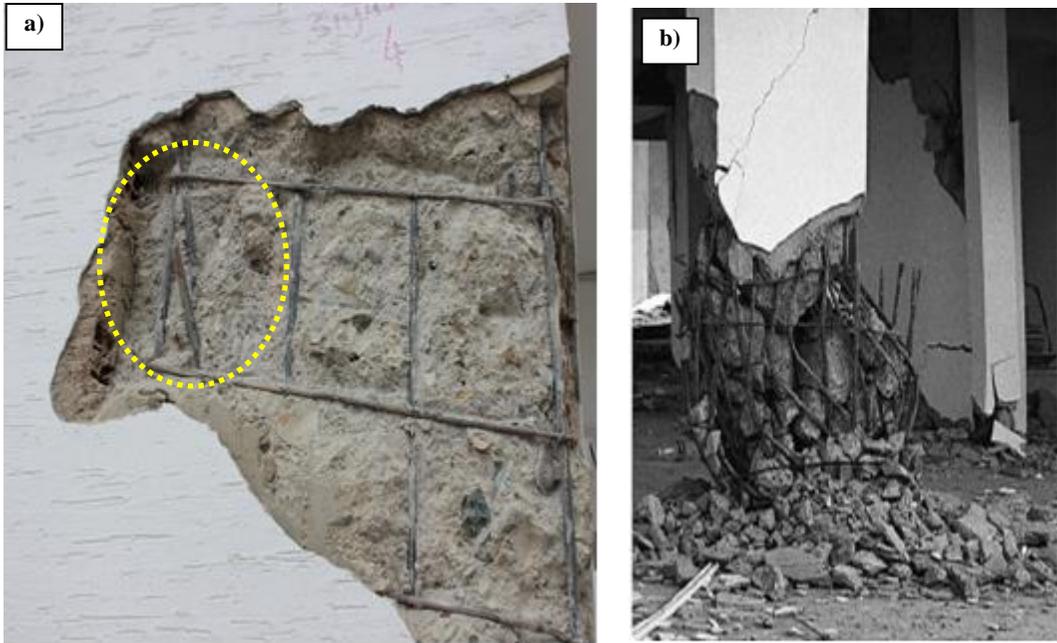
According to the TEC 2018, it is mandatory that the lap splice of the column's longitudinal rebar be made in the middle third of the free height of the column for high ductility level column. Some views of the lap splice errors observed after the past earthquake are given in Fig. 10.

**Fig. 10.** Observed lap splice errors (a) Elazığ-Sivrice and (b) Kocaeli [13] earthquakes

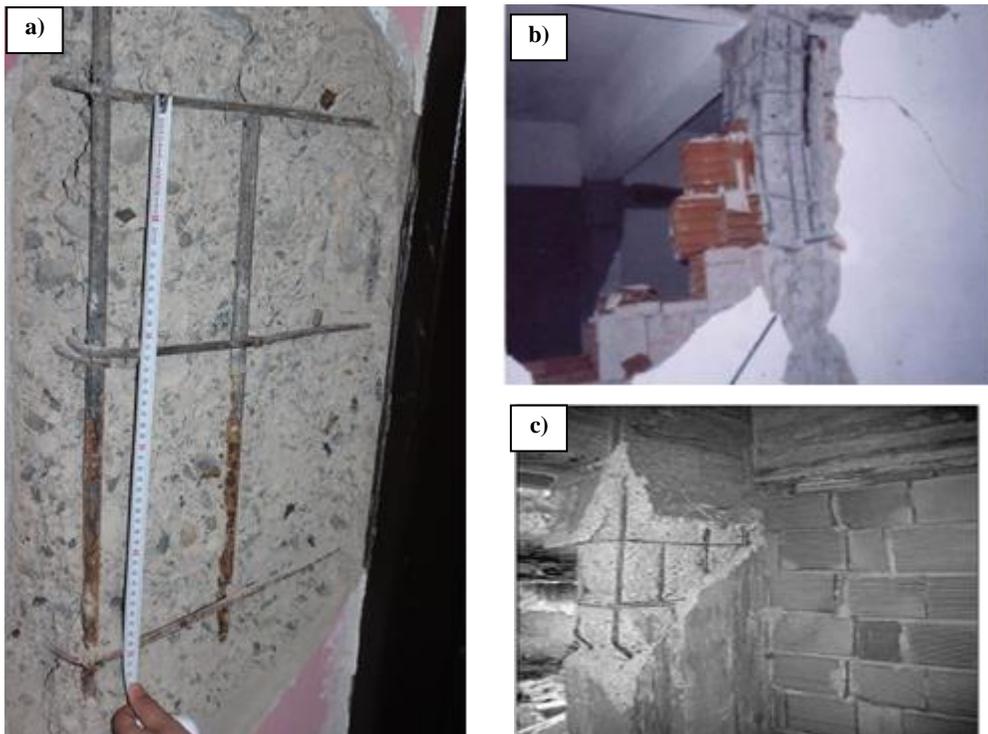
The main functions of the transverse reinforcement in the RC structural elements are to prevent buckling of longitudinal reinforcement, increase the ductility of core concrete and resist the shear force. To prevent these failures, detailing and spacing restrictions given in the regulations must be followed. Two special zones such as confinement and central zone were defined for transverse reinforcement requirements for columns and beams in the TEC after 1975. However, observations made after the earthquakes were showed that these requirements did not considered to some of the damaged or collapsed reinforced concrete buildings (Fig. 11).

**Fig. 11.** Insufficient transverse reinforcement damages observed after (a) Elazığ-Sivrice, (b) Bingöl [14] and (c) Kocaeli [13] earthquakes

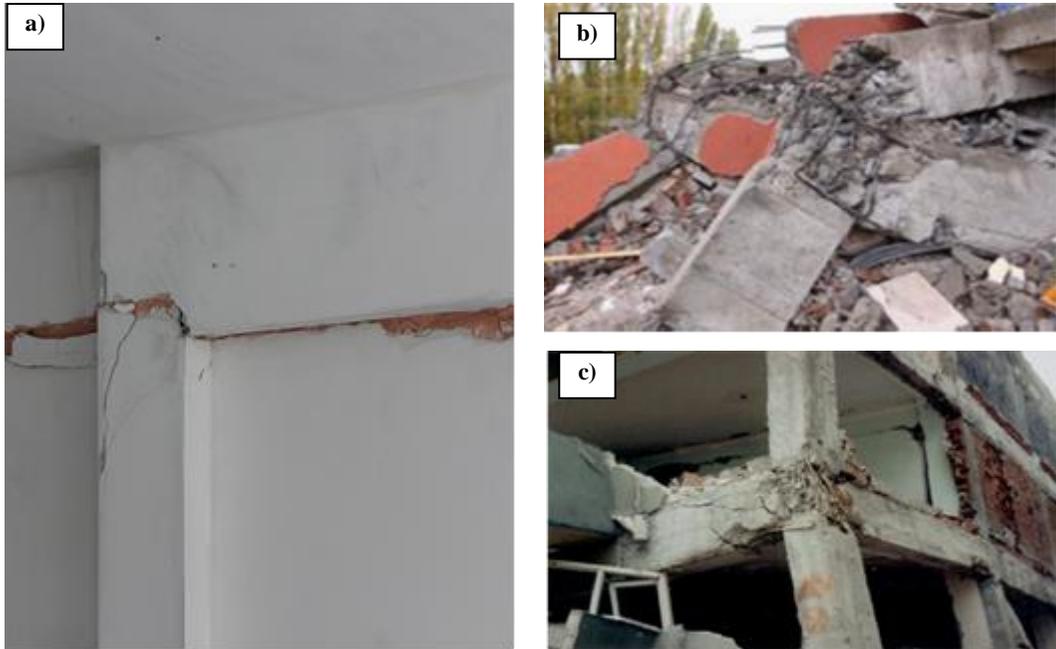
In order to ensure sufficient rigidity on the column-beam connections, these connections should be confined with sufficient stirrup. Sufficient stirrup prevent shear failure of beam-column joints. The

collapses and damages caused by column-beam connection failures in past earthquakes are shown in Fig. 12.

**Fig. 12.** Column-beam connection failure damages observed after (a) Elazığ-Sivrice, (b) Van [21], and (c) Kocaeli [13] earthquakes

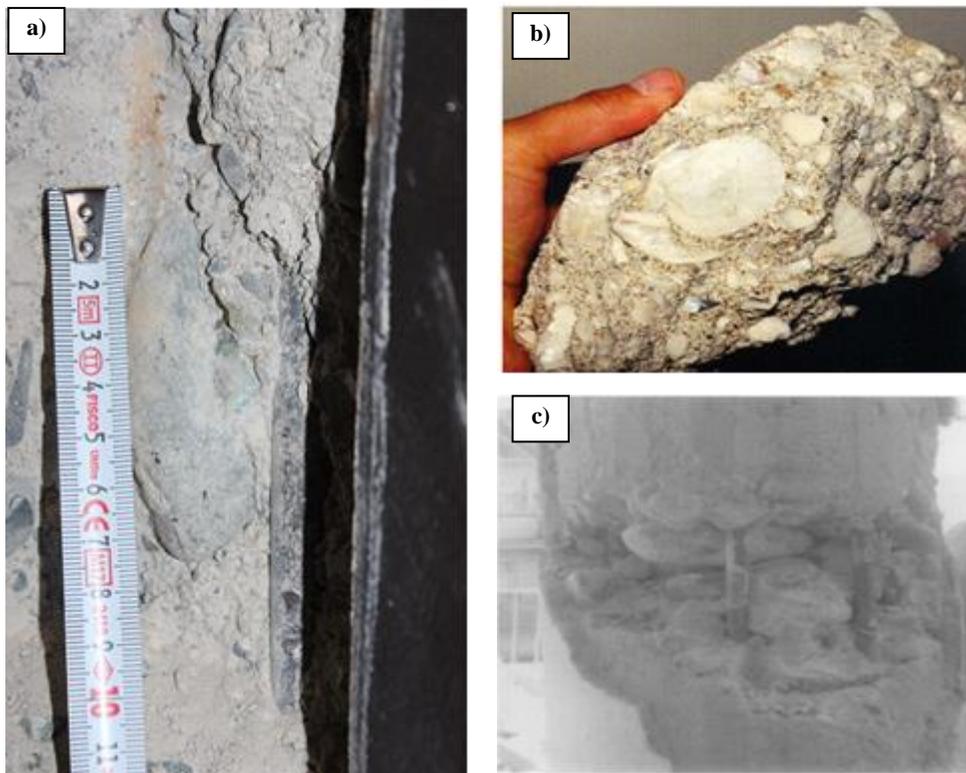
The structural performance of RC buildings largely depends on the quality of concrete. In this context, minimum concrete quality has been determined for RC buildings in the past codes. According to the TEC 1975 and the TEC 1998, minimum characteristic strength of the concrete was suggested as 18 MPa and 20 MPa, but according to the TEC 2007 and the TEC 2018, minimum characteristic strength of the concrete was raised to 20MPa and 25MPa, respectively. Although the regulations imposed restrictions on the quality of concrete, it has observed that the concrete quality of the damaged or collapsed buildings in past earthquakes was well below these limits. In addition, it has been observed that inappropriate size distributions and weak round aggregates contain clay and silt was used in concrete manufacturing [14-16, 21]. Fig. 13 display the some photos related to poor concrete quality determined in damaged or collapsed RC buildings in past earthquakes.

**Fig. 13.** Poor concrete quality observed after (a) Elazığ-Sivrice (b) Kocaeli [16] and (c) Bingöl [15] earthquake

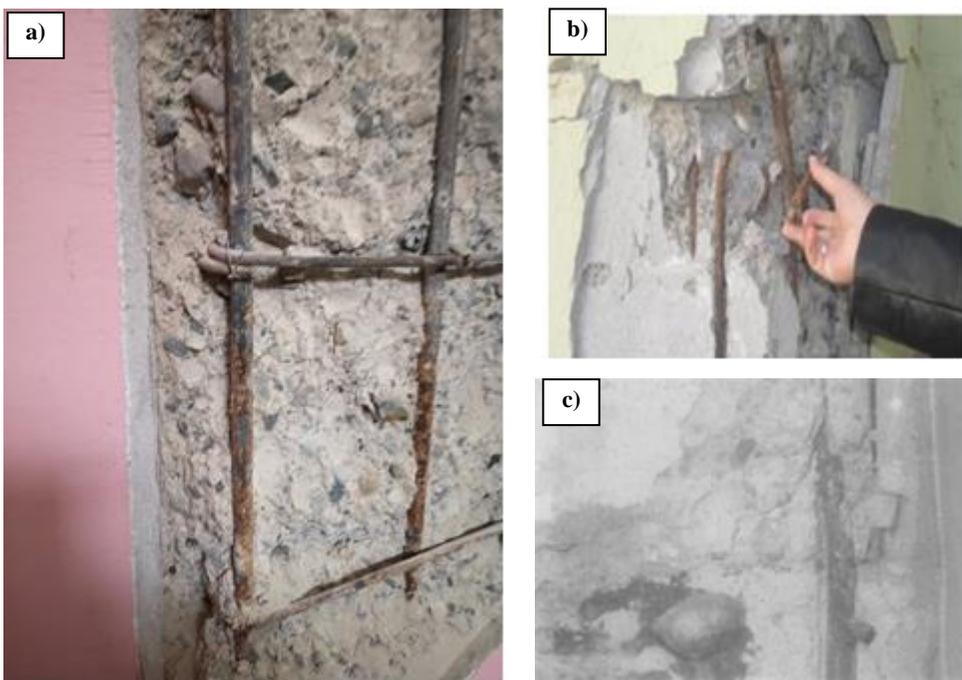
The usage of the unribbed reinforcement steel had been allowed in the TEC 1975, but the usage of ribbed reinforcement steel was made obligatory in the TEC 1998. Unribbed reinforcement steel having 220 MPa yield strength, and a combination of unribbed reinforced steel with the poor quality concrete cause weaker bond. The use of unribbed reinforcing bar in damaged or collapsed RC buildings in past earthquakes is shown in Fig. 14. Poor concrete quality, insufficient concrete cover and the absence of waterproofing at the basements increase permeability and this is concluded with the corrosion of the reinforcement steel. Corrosion causes to decrease the cross-section area of the reinforcement bar and the weaker bond between the concrete and reinforcement steel. Observed reinforcement steel corrosion in damaged or collapsed RC buildings in past earthquakes is shown in Fig. 14.

**Fig. 14.** The use of unribbed reinforcing bar and corrosion problems observed after (a) Elazığ-Sivrice, (b) Van [19] and (c) Bingöl [15] earthquakes

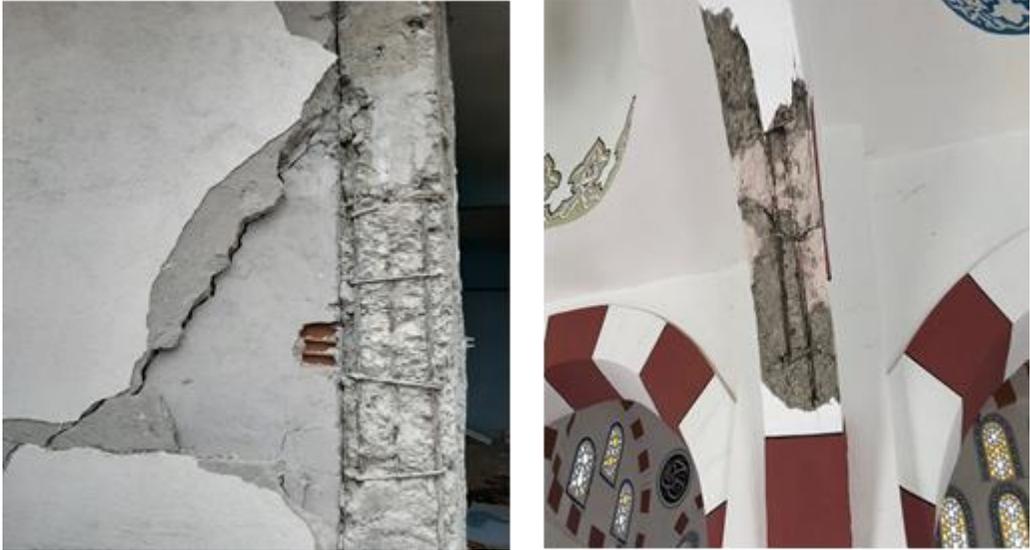
One of the most important parameters to affect the performance of RC buildings is the placement of reinforcement bars. Therefore, special attention should be given to the design and application of the transverse and longitudinal reinforcement of structural elements such as beam and column. Past earthquakes showed that a lot of RC buildings collapsed or damaged because of incorrect placing of reinforcement bars (Fig. 15).

**Fig. 15.** Incorrect placing of reinforcement bars observed after Elazığ-Sivrice earthquake

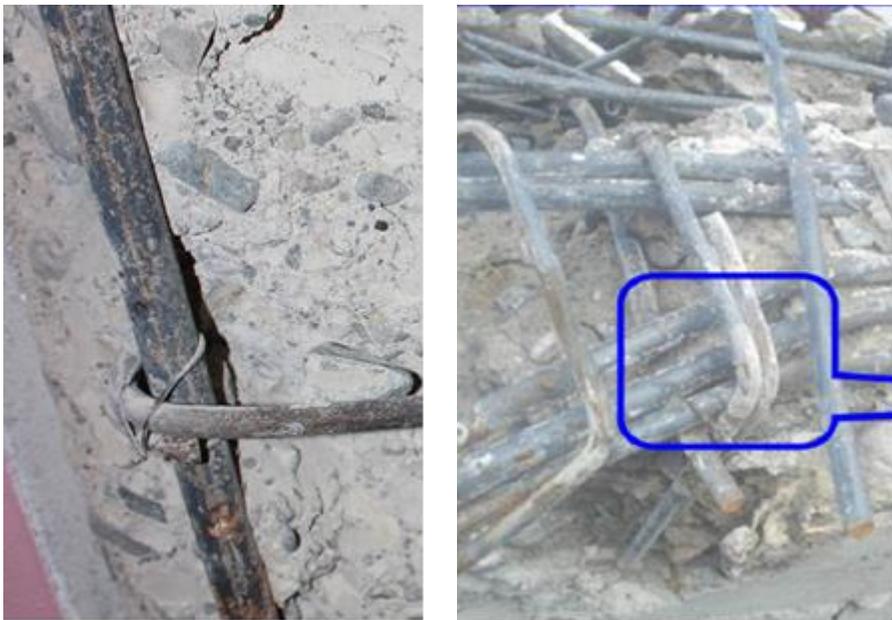
It is stated in the TEC 1975 that “*end hook angles of the transverse reinforcements must be 135° in the confinement region, and can be 90° or 135° in the middle region. Also, length of the end hook must be 10 times the reinforcement bar*”. However, previous observations show that end hook angles were 90° and hook lengths were insufficient (Fig. 16). The transverse reinforcements of the columns and beams that did not have the correct hook angles and lengths were opened up during the earthquake excitation.

**Fig. 16.** Incorrect end hook angle and length observed after (a) Elazığ-Sivrice and (b) Van [31] earthquakes

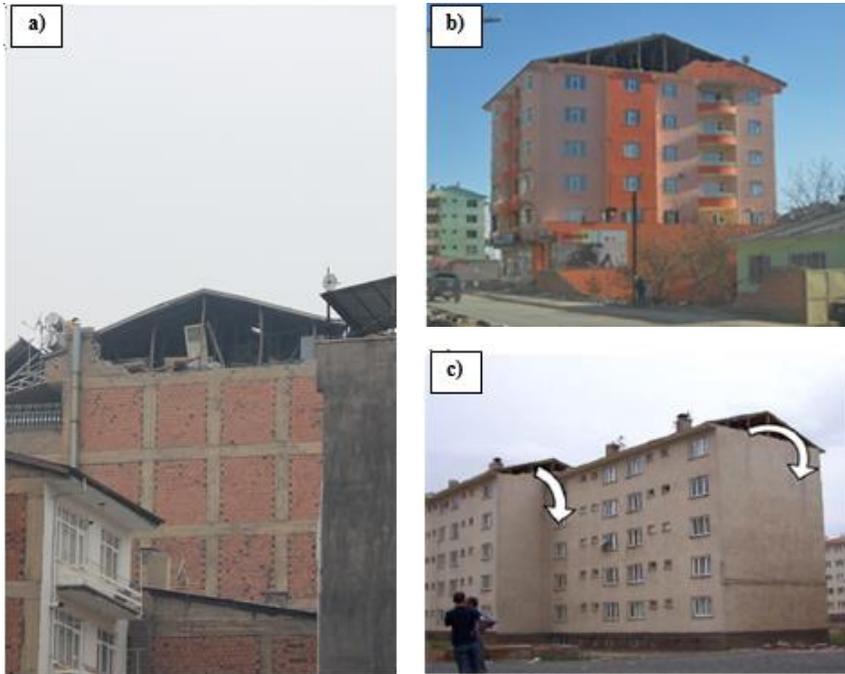
Roof floors of some RC buildings are generally closed gable walls constructed with some kind of brick or briquette. When these walls are not confined sufficiently, they fall down during an earthquake and cause loss of life and property (Fig.

17). TEC (1968, 1975, 1998 and 2007) stipulate that if the height of the gable walls resting on the horizontal bond beam at the top storey exceeds the 2.0 m, vertical and inclined bond beams should be constructed. The height limit (2.0 m) is updated to be 0.80 m in TBEC (2018).

Fig. 17. Weak gable wall damages observed after  
(a) Elazığ-Sivrice (b) Van [19] and (c) Bingöl [14] earthquakes

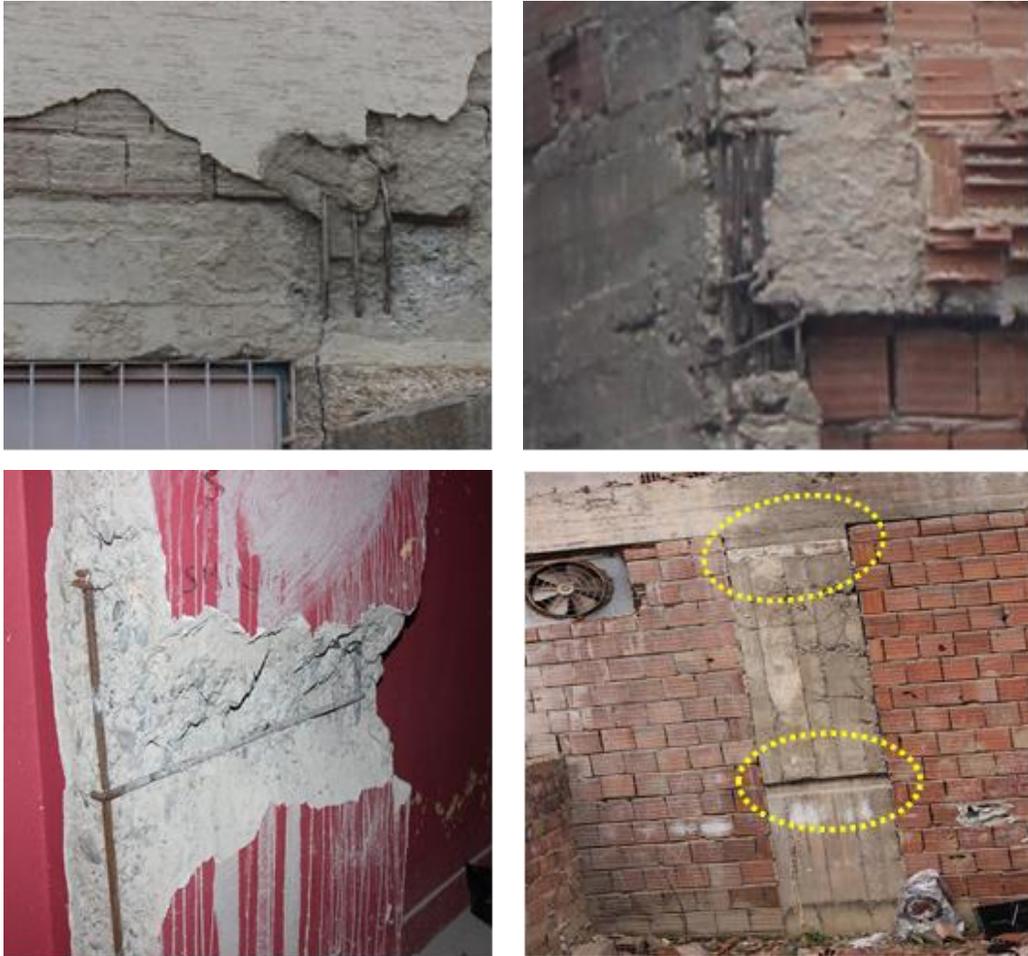
The design of RC buildings is as important as the process of the construction made by workmen. Although the building has an accurate design, the performance of the building depends on attention and care during construction. Observed workmanship defects in damaged or collapsed reinforced concrete buildings in past earthquakes are shown in Fig. 18.

**Fig. 18.** Workmanship defects observed after Elazığ-Sivrice earthquake

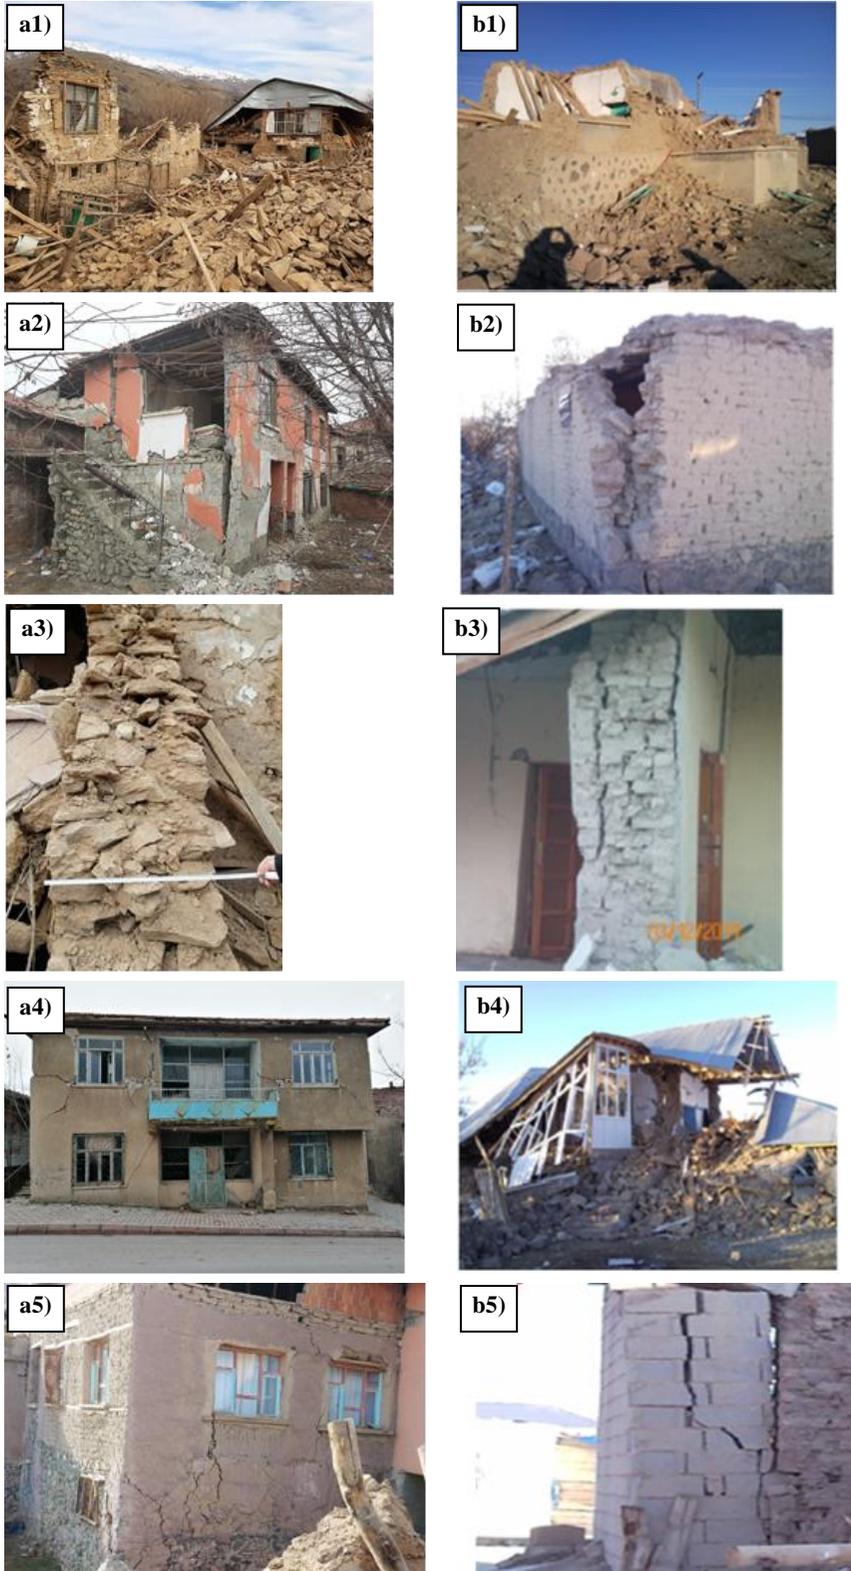
of masonry buildings was not good and caused many property and life losses. Previous reports and 24 January 2020 Elazığ-Sivrice earthquake field observations indicated that the poor quality of construction, inadequate material properties, heavy earth roofs and weak gable walls are general reasons for insufficient dynamic performance of masonry buildings.

Fig. 19. The poor quality of construction damages observed after (a) Elazığ-Sivrice, and (b) Van [33] earthquakes

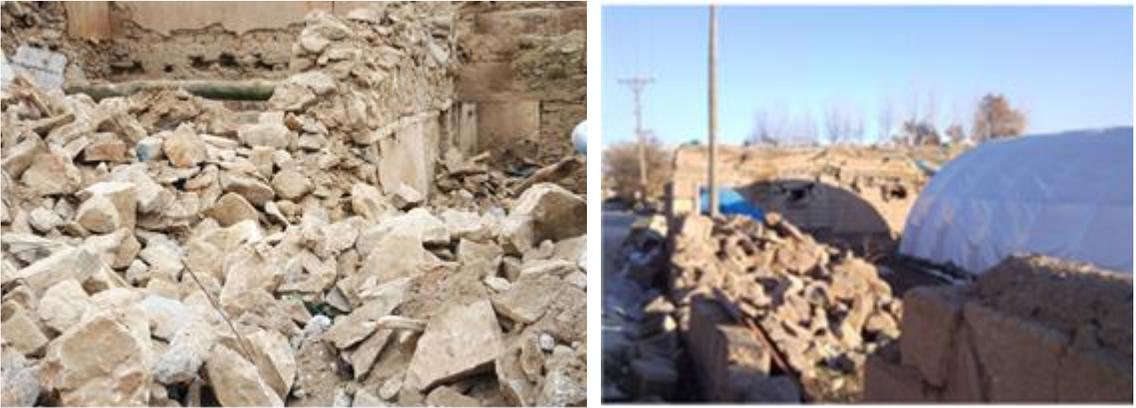
Masonry structures transmit most of the horizontal and vertical loads to the foundation through their load-bearing walls. The strength of the wall is directly related to the strength of the materials that make up the wall. According to the TEC 1998, natural stone, solid brick or bricks with vertical holes are used for the construction of the wall and the compressive strength of these materials cannot be lower than 50kg/cm<sup>2</sup>. Also the shape of the natural stone is very important to ensure enough adherences between stones and mortar. Not proper shaped stones (smooth, round and irregular shape) cause low adherences. Natural stones should be used after shaped them into the proper shape and dimension. Insufficient binder property between stones or bricks is another reason to cause damage and collapse of masonry buildings. The lime mortar supported with cement or cement mortar should be used in walls as a binder material. But, due to the economical reason, mud mortar is generally used between stones and bricks (Fig. 20).

**Fig. 20.** Inadequate material properties damages observed after (a) Elazığ-Sivrice, and (b) Van [33] earthquakes

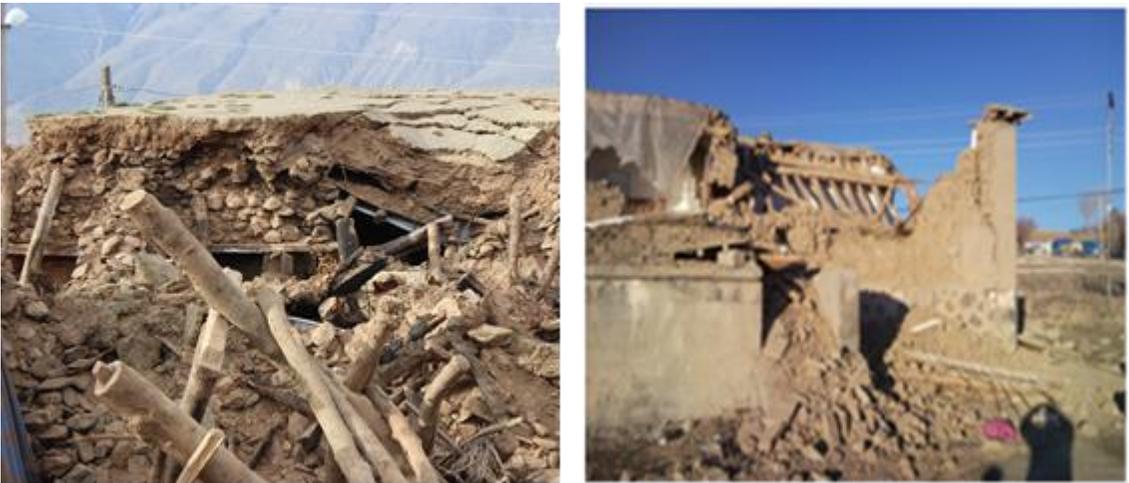
Traditionally, the roofs of masonry building in some rural region are covered with earth over the wooden locks to prevent water leakage and for heat isolation in both cold and hot season. The thickness of these roofs sometimes reaches to 1.0m. Thus, the weight of the structure increases, causing the additional lateral forces that affects the structure during the earthquake (Fig. 21).

**Fig. 21.** Heavy earth roofs damages observed after (a) Elazığ-Sivrice, and (b) Van [33] earthquakes

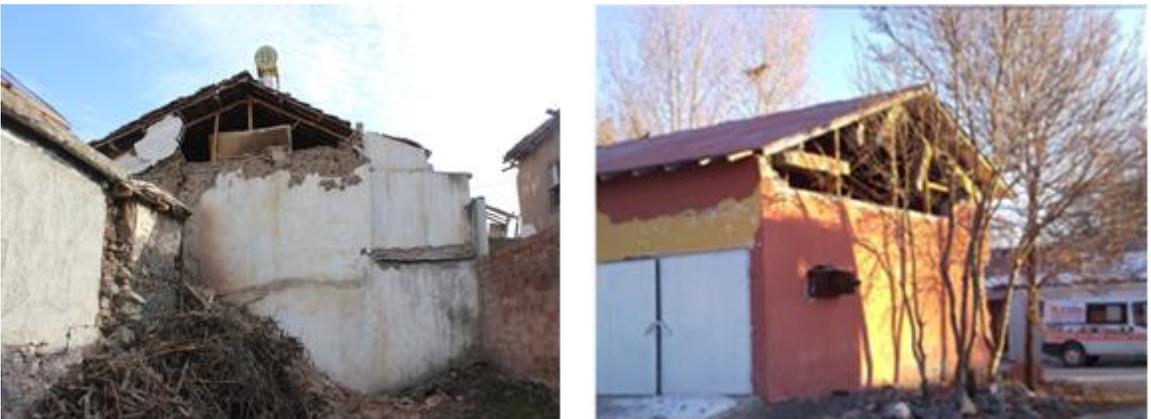
The roof floor of some masonry buildings are generally closed with gable walls constructed by using some kind of brick or briquette. When these walls are not confined sufficiently, they fall down during an earthquake and cause loss of life and property (Fig. 22).

**Fig. 22.** Weak gable walls damages observed after (a) Elazığ-Sivrice, and (b) Van [33] earthquakes
