# Damage assessment of a cement plant partially collapsed depending on various causes

This study aims at examining the possible causes of the brittle collapse of a tertiary air duct system under vertical loads. Problems related to the design and construction stages were examined. The entire process was illustrated using a tertiary air duct case study in a cement plant. In the plant, the tertiary air duct collapsed without any earthquake, blast, or impact effects. The current study includes a field study, examination of an original/revised design project, and numerical simulation. In the first stage of the study, the existing state of the collapsed system and its compliance with static and mechanical projects were examined. Secondly, a two-dimensional finite element analysis was performed to determine project eligibility. The causes of the system were determined based on the data obtained in the former stages. The results showed that the causes of partial collapse included project errors, construction faults, and project incompatibilities.

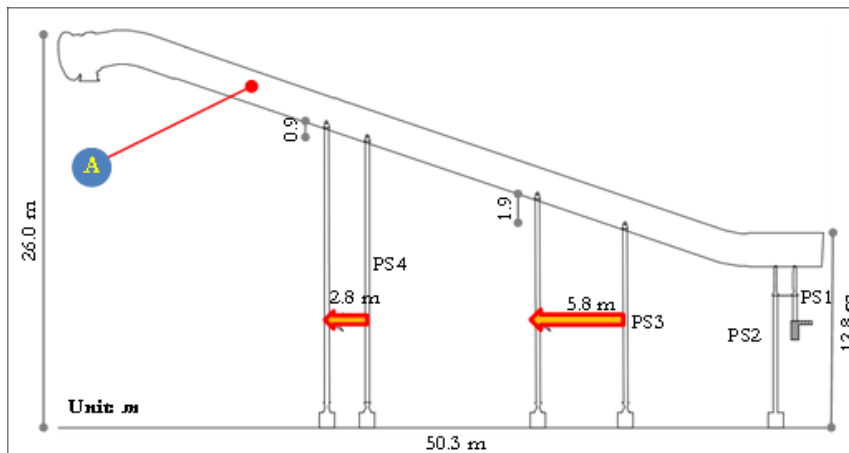
During the field survey, inspections were conducted in the collapse area. The interventions performed according to the revised static project and mechanical project were visually examined to determine whether the projects were carried out accurately. Data about the possible causes of the collapse were also obtained during the field survey. Fig. 5 provides the post-collapse images of the duct (indicated by A in Fig. 3). The duct and column movements during the collapse are schematically shown in Fig. 6.

**Fig. 3.** Overview of tertiary air duct and the column movements

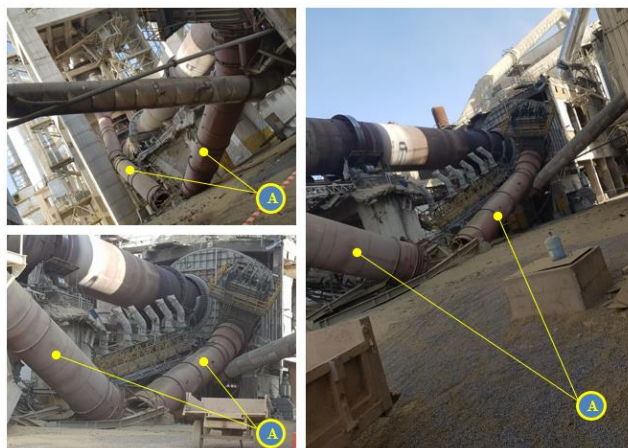
**Fig. 5.** View of the collapsed duct system

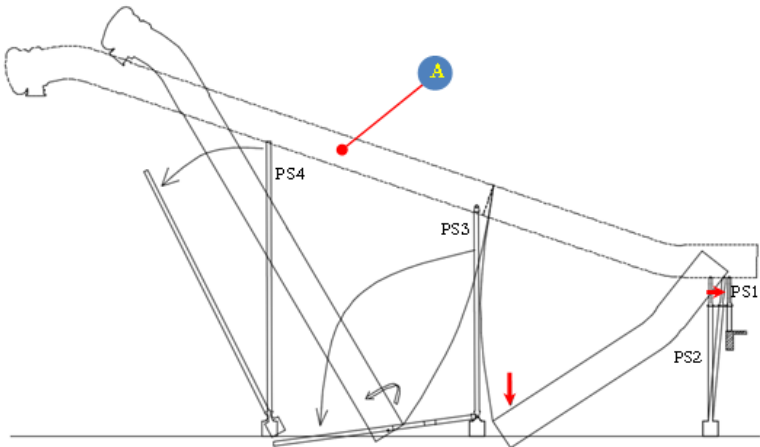
Fig. 6. The schematic view for the collapse of the duct system

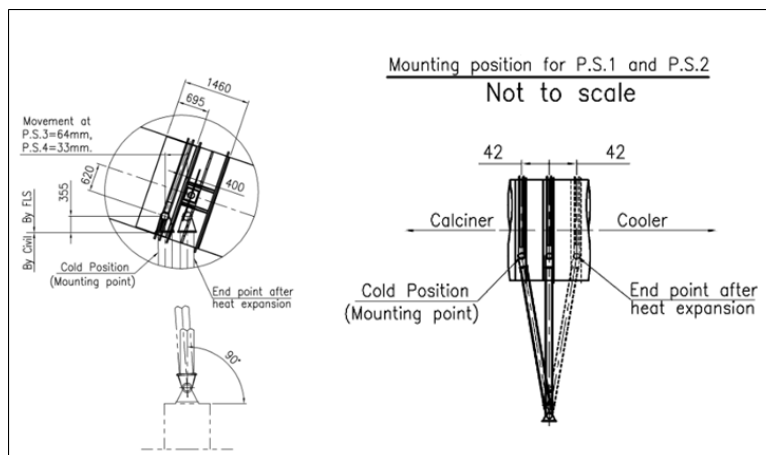
During the field survey, we detected that some construction practices were not consistent with the static and mechanical projects. The cold position of the column footings was mounted incorrectly. We found that the cause of this fault was due to the column movement; the mounting positions in the mechanical project were not changed according to the revision in the static project [23]. However, the mounting positions could not be determined in the post-collapse examination (Fig. 8). Also, the RC column dowel dimensions were not consistent with the static design project. Although anchorage length for vertical rebars was specified in the static project as 30 cm [9], the actual anchorage length was measured to be approximately 8 cm in the field study (Fig. 9).

**Fig. 8.** Cold and hot-footing positions in the mechanical project (before and after expansion)

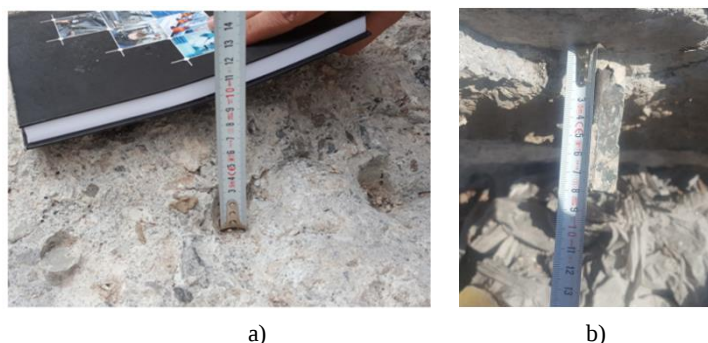
**Fig. 9.** Anchorage lengths (a, b)

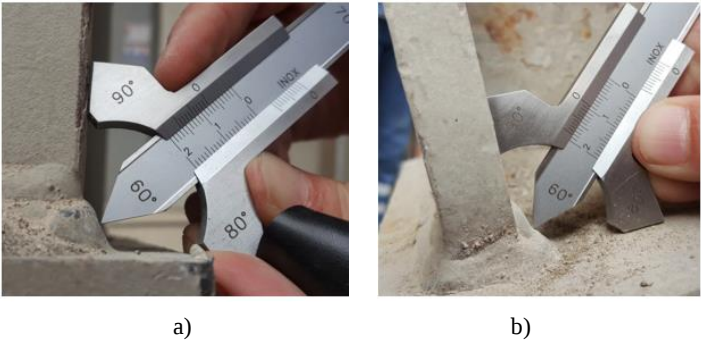
Although the thickness of the corner weld in the PS1 column footing-base plate joint should be 10 mm according to the static project, the actual welding thickness was measured to be 7 mm (Fig. 10). Furthermore, according to the design project, 12M16 anchor bolts should have been used in the PS3 and PS4 column footings. However, the field investigations revealed that 4M20 and 3M20 anchor bolts were used in PS4 and PS3 column footings, respectively (Fig. 11). According to the mechanical project, the lower and upper welds connecting the pin to the pipe should have been made by opening a welding mouth. The project states that there should be a 28 mm welding mouth on the 30 mm thick lower layer and a 12 mm welding mouth on the 15 mm thick upper plate. However, as seen in Fig. 12, the field investigation showed that the pin was welded without opening a welding mouth.

**Fig. 10.** Weld thickness measurements (a, b)

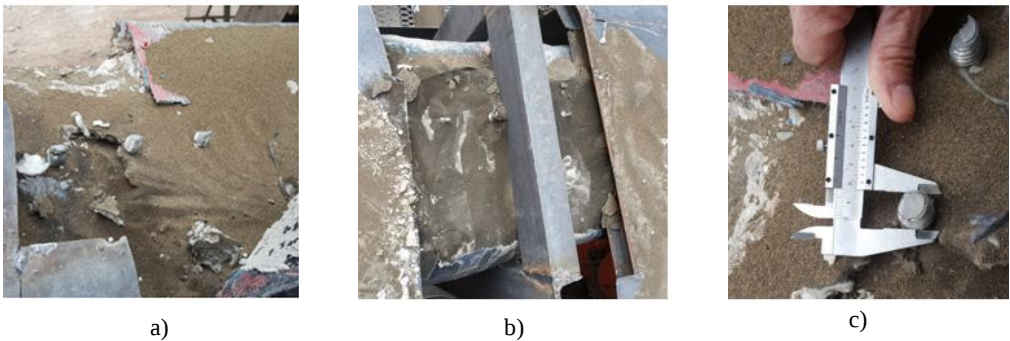
**Fig. 11.** Anchorage measurements (a-c)

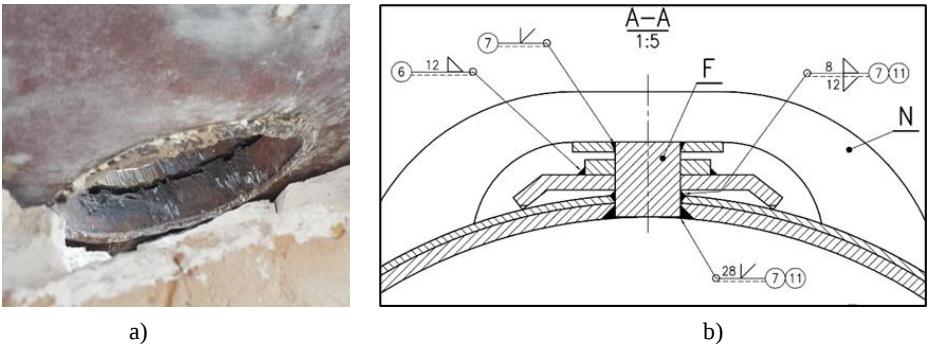
**Fig. 12.** View of sub-welding in pin used for the duct attachment. (a) Actual image, (b) Project

We found that the pin on the duct system did not comply with the project requirements. However, a system collapse is still possible regardless of the accuracy of the pin application. Because the mechanical project was extensively revised. With this revision, the duct span increased to 16 m from 10 m, and thus, the duct section was exposed to increased moment forces by 2.6 times. This increase caused a change in the loads to which both the pins and the column ends were exposed. Therefore, the construction practice without properly revising the mechanical project is the main cause of the collapse.

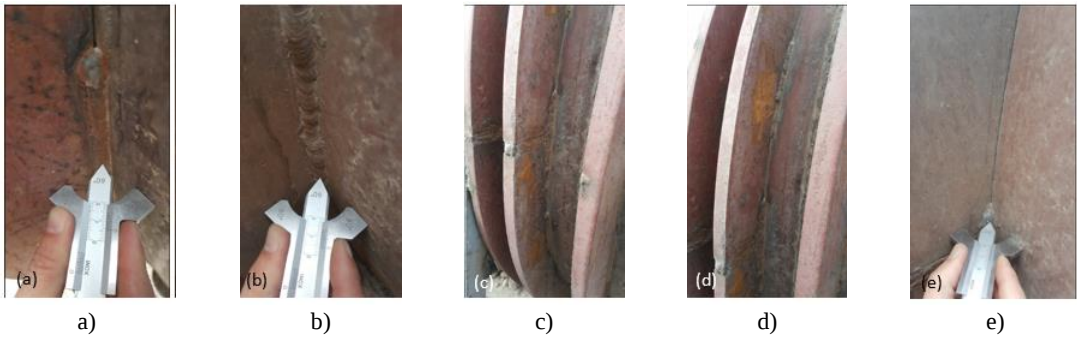
According to the mechanical project, the welds for the external ribbed plate should be 50–200 mm double-sided with a 10 mm corner welding. However, we observed that these welds did not comply with the dimensions specified in the project (Fig. 13). Moreover, in the mechanical project, welds for the duct attachment were defined as fully penetrated V-shaped welds by opening welding mouths to both plates. On the other hand, the field examinations showed that the actual welds did not comply with these requirements (Fig. 14).

**Fig. 13.** External ribbing weld for the duct (a-e)

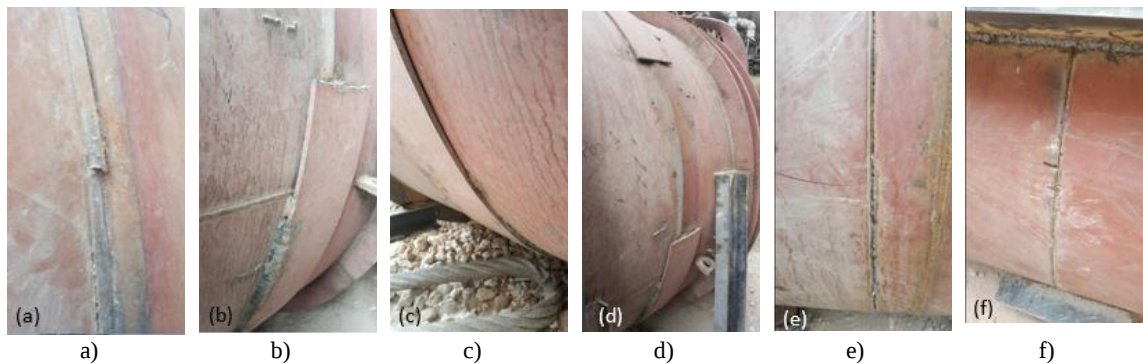
Fig. 14. Additional weld for the duct (a-f)

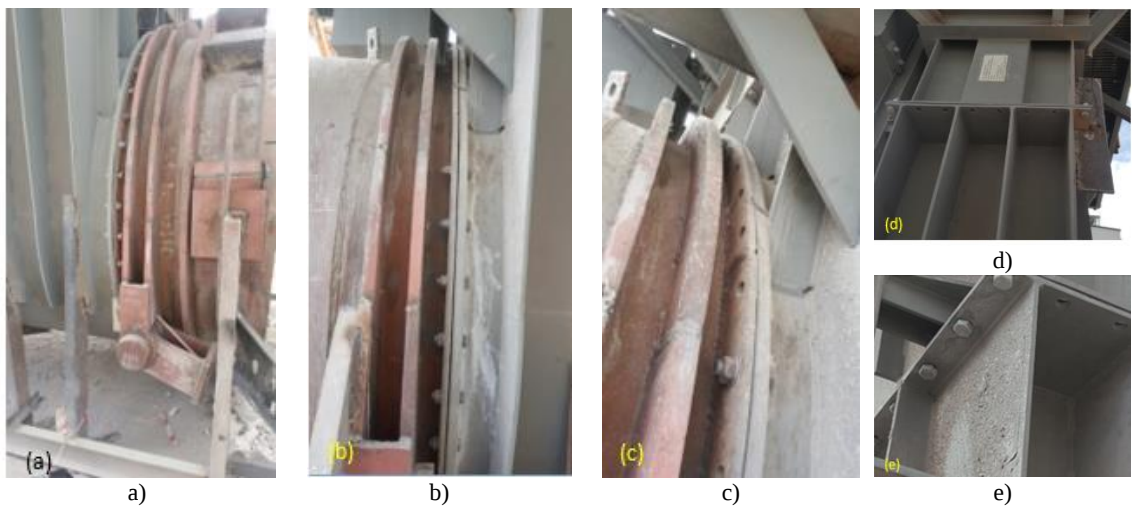
Although the mechanical project stated that there should be no missing bolts, some missing bolts were determined in the field inspections. (Fig. 15). Moreover, the project described that the lock plate, which was supported perpendicular to the pin cover, should be combined with 12 mm thick corner welds on both sides. However, these corner welds were not observed in the field study (Fig. 16).

Fig. 15. Missing bolts detected in the hoisting damper (a-e)

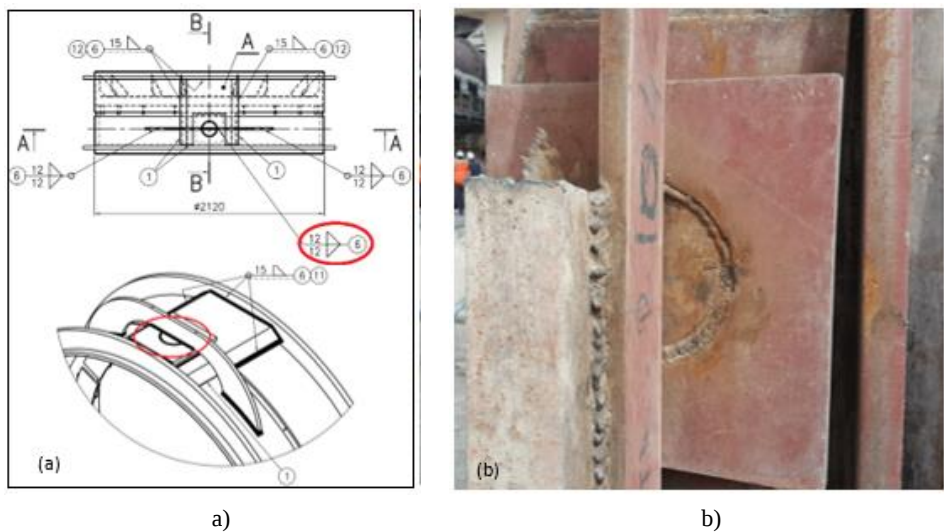
Fig. 16. Missing weld on the lock plate of the pinning zone (a, b)

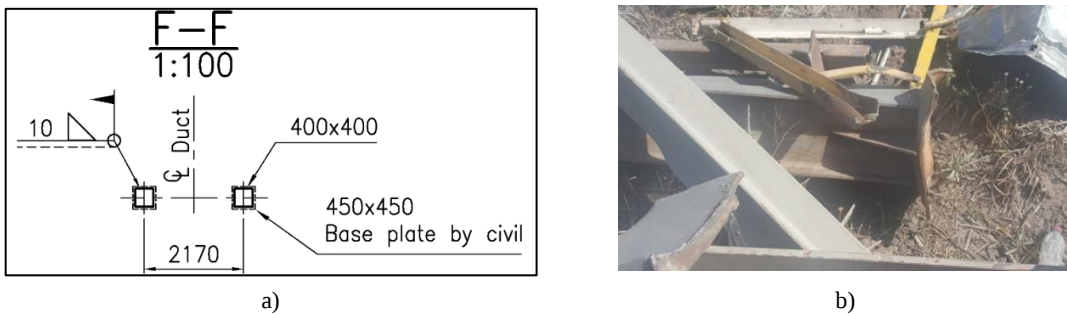
According to the revised static project, a  $400 \times 400 \times 8$  mm plate should be placed over the PS3 column (Fig. 17a). However, this plate was described as  $450 \times 450 \times 14$  mm in the mechanical project. In addition, according to the mechanical project, the base plate of the upper joint should be connected to the plate over the column with a 10 mm corner weld. In the field study, we determined that the maximum deformations occurred on this plate (Fig. 17b).

Dimensions of the plate located at the end of the PS3 column in the revised static project did not comply with the mechanical project. In other words, plate dimensions and weld thicknesses did not comply with the project requirements. This defect can cause structural problems under earthquakes due to the great difference between the project and the actual practice in terms of the number of materials. However, it seems highly unlikely that the structure collapsed due to the compressive that the plate was subjected to under service loads. As shown in Fig. 18, it was observed that the column rotated towards to HE260B beam approximately 150 degrees during the collapse. Therefore, it is understood that the weld was still intact when the collapse started.

**Fig. 17.** (a) Column endplate (mechanical project), (b) View of column endplate after the collapse

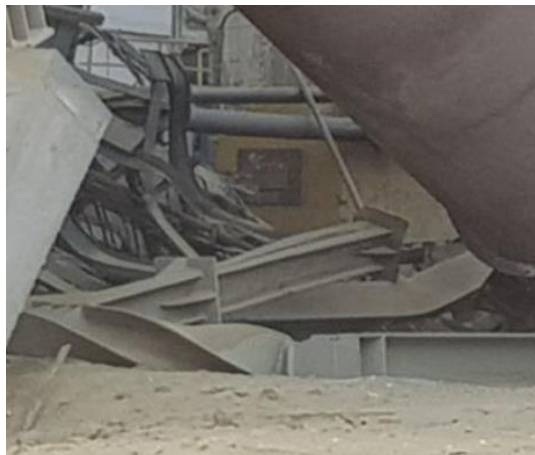
**Fig. 18.** View of the column after the collapse

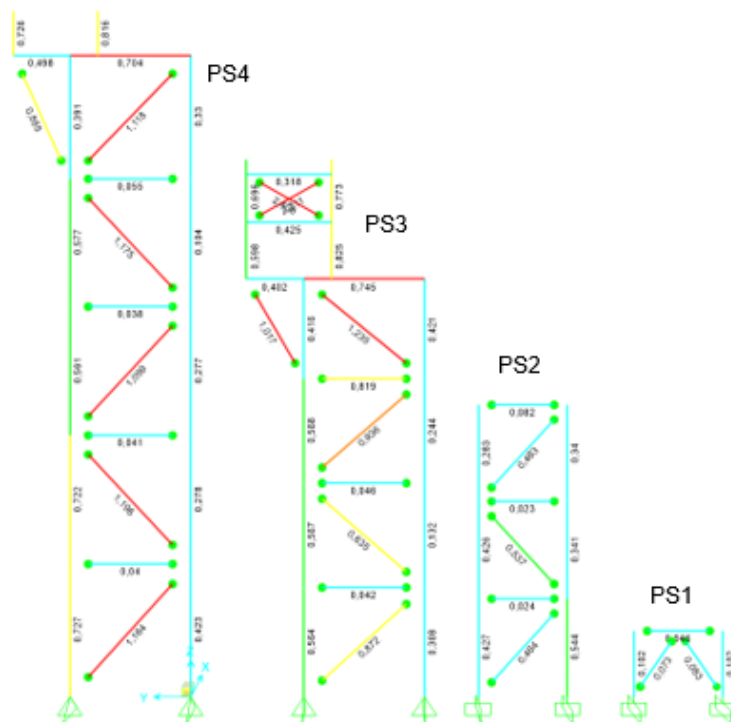
Fig. 19 provides design control results under the most unfavorable loading. Capacity ratios are also provided in this figure. The capacity limit was defined as “1”. Accordingly, a number more than 1 indicates that the corresponding member has inadequate strength. The members with inadequate strength are indicated in red (Fig. 19). According to selected specifications and load combinations, 15-25% variation in element capacity values was considered within reasonable limits. If the structure had collapsed due to long-term use or earthquake damage, different load types should have been taken into account in the structural analysis. However, the duct system collapsed only two months after the modernization is completed, without any earthquakes, wind, and/or snow loads. For a realistic modeling study, dead and live loads were considered in the numerical study. Accordingly, the design was examined regarding the combination of the duct weight, insulation loads, and dust accumulation. The results obtained are given in Fig. 20. The connection plate section was exposed to a shear force of 327.3 kN and a moment of 16.1 kNm. Considering the safety stress for an 8.8 quality M20 bolt, the allowable load-bearing and the joint shear capacities were calculated as 59.7 kN and 358.2 kN, respectively. Deformation has occurred in the steel material before the shear-induced rupture of the bolts in all connections. Considering the joint and the axial forces on the bolts caused by the bending moment, we determined that the factor that initiates the collapse is not related to these insufficient strengths.

Fig. 19. Analysis results for the most unfavorable load combination

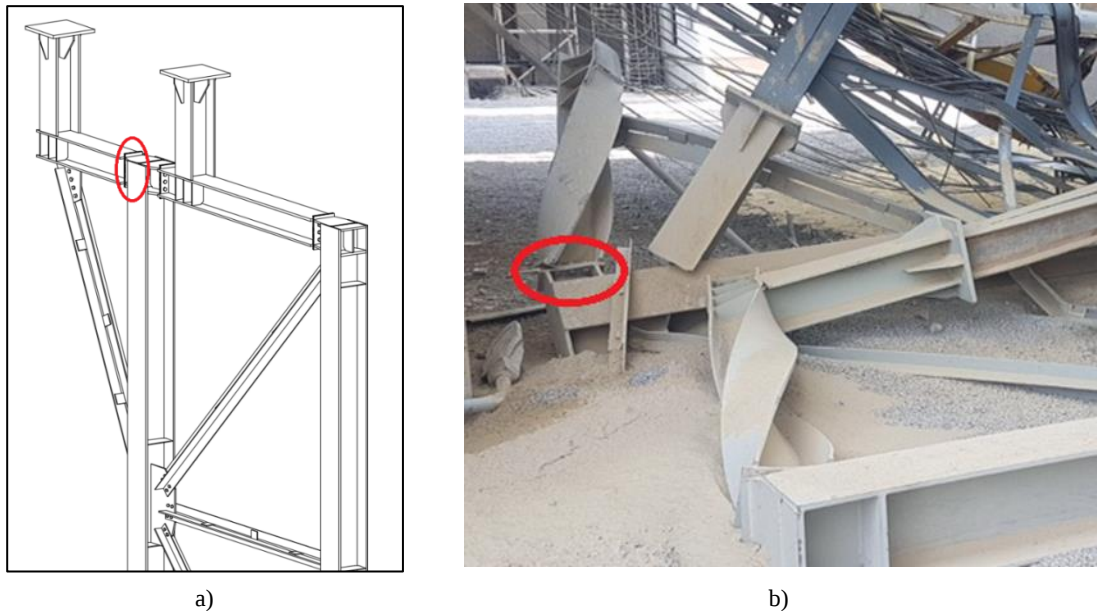
We determined that in the revised static project, the strength of the console placed to out-of-plane loads was insufficient. This joint exhibited only a hinge behavior. Since there was not enough data on the out-of-plane loads used in the design process, the analyzes could not be done in the 3D model, so a 2D model was developed and used in numerical studies.

Torsional behavior is likely to occur as a result of the lateral load on the column. Besides, if the bolts were subjected to moment loads, ruptures must have occurred. However, we observed that the bolts did not rupture when the collapse started. The bolts behaved rigidly allowing the console beam to rotate approximately 150 degrees (Fig. 21). The post-collapse examinations of the positions of the duct parts revealed that the columns PS3 and PS4 overturned towards the preheater tower, whereas the columns PS2 and PS1 tilted in the opposite direction, towards the clinker cooler unit. The distance between the broken duct parts on the ground was measured to be approximately 6 m. As the long piece of the duct (left part) fell, the RC console rotated about 90 degrees around its axis. However, the shorter piece of the duct (right part) seems to fall flat on the ground (Fig. 22).

**Fig. 21.** Out of plane vulnerability of the console-beam connection. (a) The project, (b) Actual

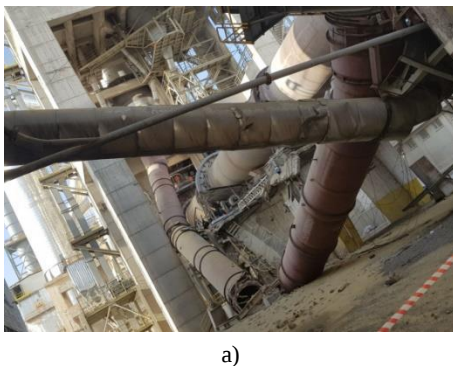
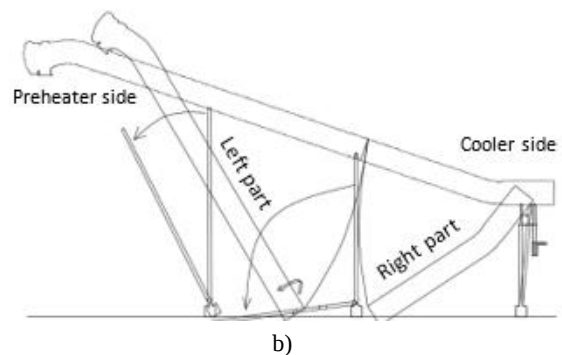
**Fig. 22.** (a) Post-collapse view of the plant, (b) Duct positions after the collapse
