## RESEARCH ARTICLE

## On the earthquake-related damages of civil engineering structures within the areas impacted by Kahramanmaraş earthquakes

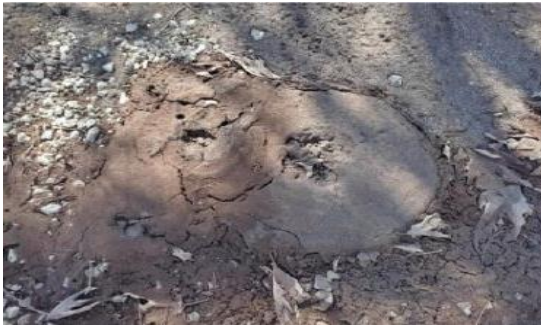
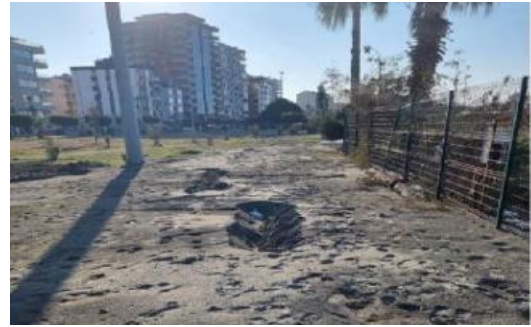
After the Kahramanmaraş earthquakes, typical damages due to soil liquefaction were observed widely in Gölbaşı in Adıyaman and İskenderun in Hatay. Sand cones formed in Adıyaman and İskenderun as a result

of soil liquefaction are given in Fig. 4. When the soil problems occurring in these districts are examined on site, it has been determined that the common defect in Gölbaşı is not liquefaction, but the loss of bearing capacity. In terms of the formation of this district, the lake sedimentation symbolizes the dominance of soft clays in the region. Soft clays tend to soften rather than liquefy under dynamic effects. As a result, it is understood that the dominance of the situation that causes the excessive deformation of these buildings in Gölbaşı is not in liquefaction, but in the loss of bearing capacity of soft clays under dynamic loads. Uniformly seated, differentially seated, and overturned buildings occurring in Gölbaşı buildings are seen in Fig. 5.

Fig. 4. Sand cones formed in Adıyaman and İskenderun as a result of soil liquefaction

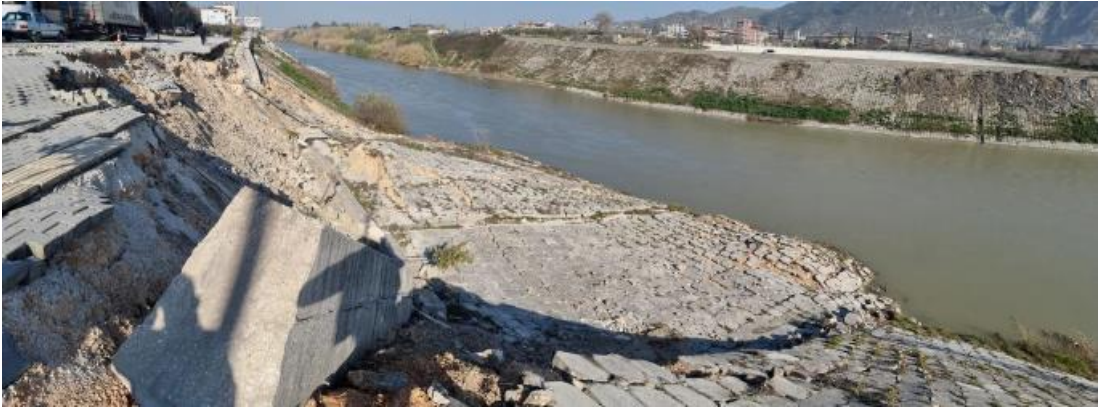
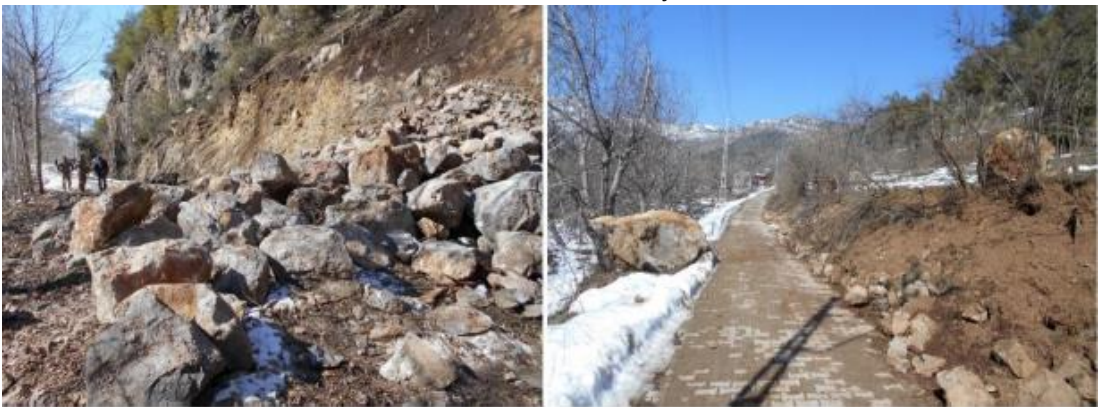
Another ground-based damage type experienced after the 6 February 2023 earthquakes is mass movements. Mass movements are defined as processes of erosion, transport, and accumulation of material that occur on both gentle and steep slopes mainly owing to gravitational forces. The mass movements occurred in Hatay and the rock falls on the Gaziantep İslâhiye Kökçü road are shown in Fig. 6.

Fig. 6. Mass movement and rock fall

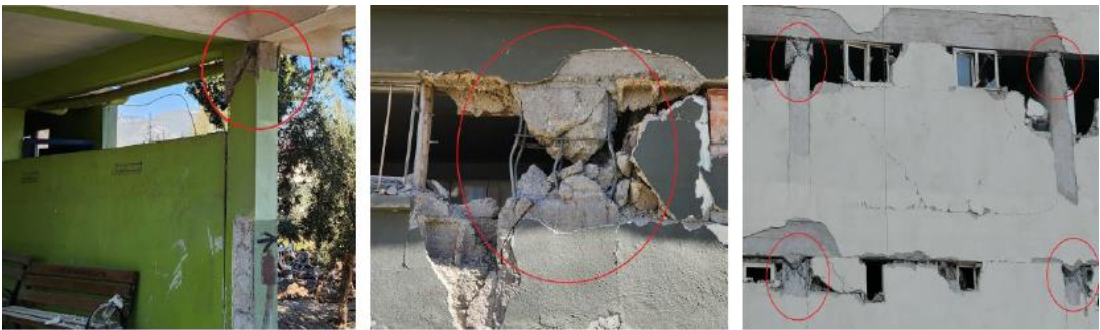
The spaces left for lighting and ventilation in the infill walls of the buildings or the half walls made in the ground and basement floors play an important role in the formation of short columns. Since the short columns formed have high rigidity and low ductility, they are damaged by shear fracture if necessary precautions are not taken under horizontal displacements. Structural damages due to short column formation were determined in field observations (Fig. 7). Column-beam connection points of RC structures are exposed to great forces under the effect of earthquakes. Excessive stresses in these regions cause structural damage. As a result of the field observations made in the earthquake zone, the damages in the column-beam regions were observed (Fig. 8). If the overlapping length of the reinforcements is insufficient, the seismic performance of RC buildings is adversely affected. To avoid such problems, it is necessary to comply with the conditions in the codes. Details of damage due to insufficient overlap length observed are given in Fig. 9.

Fig. 7. Structural damage from short column formation

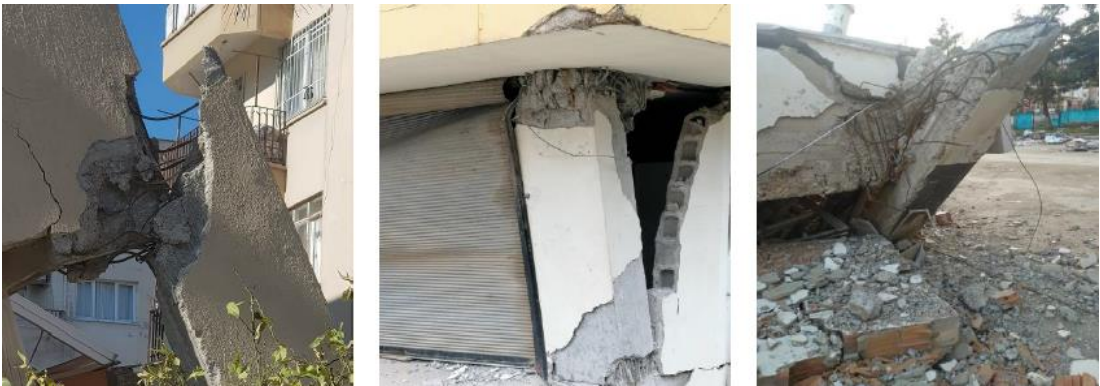
Fig. 8. Column-beam connection failures

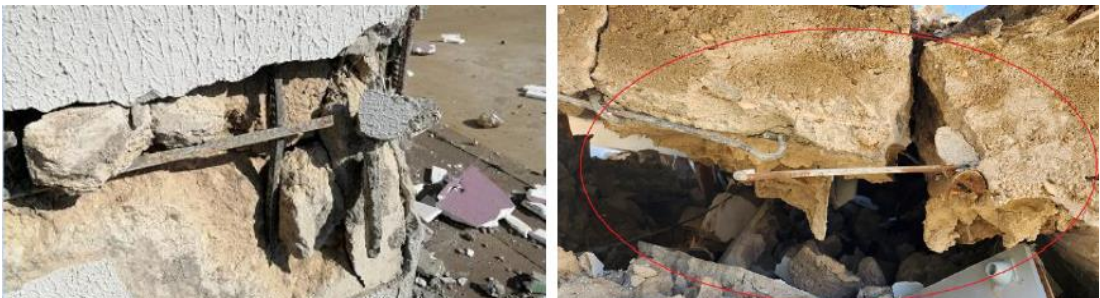
Fig. 9. Existence of short and unconfined lap splices

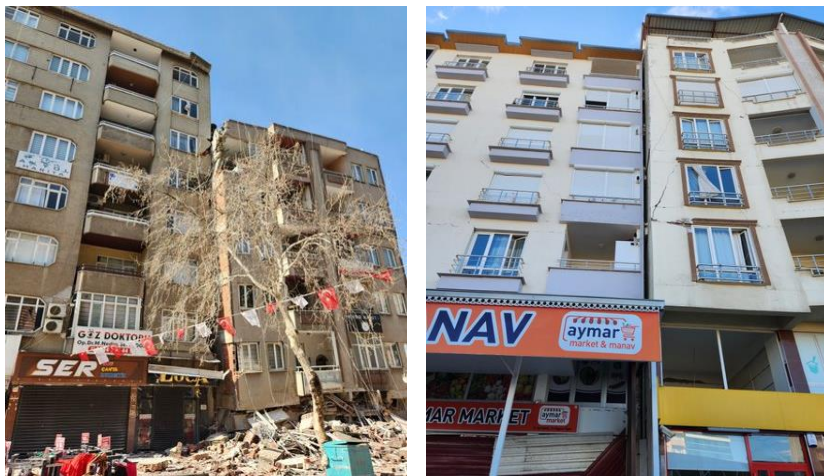
Adjacent structuring is frequently encountered in Türkiye. However, if there is not enough space between these structures, horizontal movements of buildings can have destructive effects on each other (Fig. 10). The transverse reinforcements used in RC structural elements have main functions such as preventing buckling of the longitudinal reinforcements, increasing the ductility of the core concrete, increasing the compressive strength of the core concrete and meeting the shear forces. As a result of the field observations made in the earthquake zone, it was observed that the requirements given in the codes were not taken into account in the selection and placement of the transverse reinforcements, and the damages that occurred due to this reason are given in Fig. 11. A floor system consisting of evenly spaced shallow beams and a thin plate is called rib flooring. In rib flooring systems, a hollow floor system is obtained by filling the gaps between shallow beams with non-bearing building materials. They are preferred due to the reduction in mold and plaster workmanship, and the architectural advantages that allow economical and fast production. This type of flooring creates problems in terms of beam-column connection performance (Fig 12). In TBEC-2018, situations that cause irregularity in buildings are defined under two headings as irregularities in the plan and the vertical direction. Irregularities in the plan are classified as torsional irregularity (A1), slab discontinuities (A2), and projections in plan (A3), while the weak story (B1), soft story (B2) and discontinuity of the vertical elements of the carrier system (B3) are classified as vertical irregularities. The weak story damages observed in field investigation are shown in Fig.13

Fig. 10. Inadequate safe distance

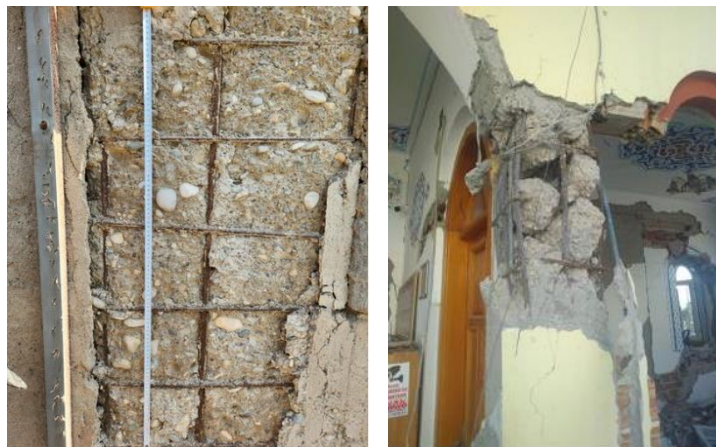
Fig. 11. Insufficient transverse reinforcement

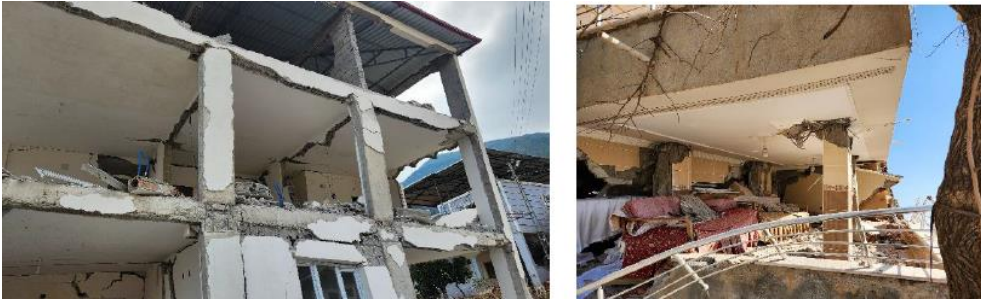
Fig. 12. Damages caused by hollow flooring application

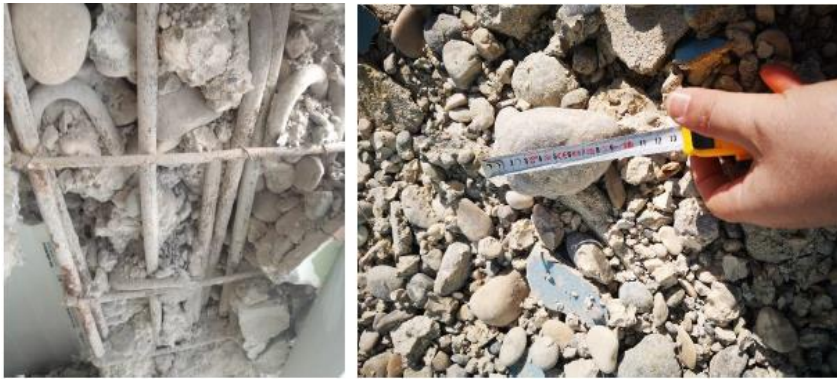
One of the biggest factors causing damage and destruction to structures in past earthquakes in Türkiye is the low concrete quality (Fig. 14). For this reason, it is seen that the quality of concrete is gradually increasing in the codes that came into force in the following years. In TBEC-2018, which is currently in force, the minimum characteristic strength of the concrete was determined as 25 MPa. For RC, to show the expected behavior, adherence must be formed between the concrete and the reinforcements that make it up. In particular, to increase adherence ribbed reinforcements are produced. The combination of non-ribbed reinforcement and poor quality concrete causes weaker adhesion formation and adversely affects the behavior of RC (Fig. 15). Incorrect placing of reinforcement bar, incorrect end hook angle and length, and weak gable walls can be defined as workmanship defects. The damages caused by workmanship defects are given in Fig. 16.

Fig. 14. Poor concrete quality

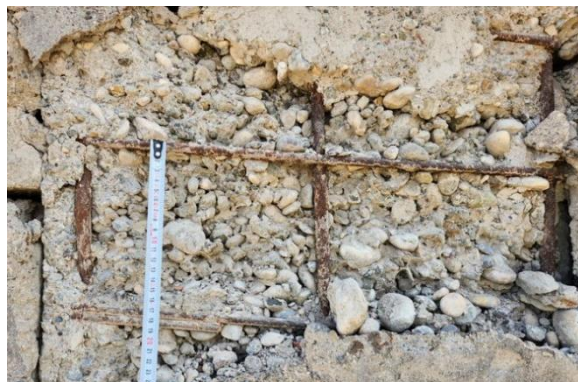
Fig. 15. Unribbed reinforcing bar and corrosion

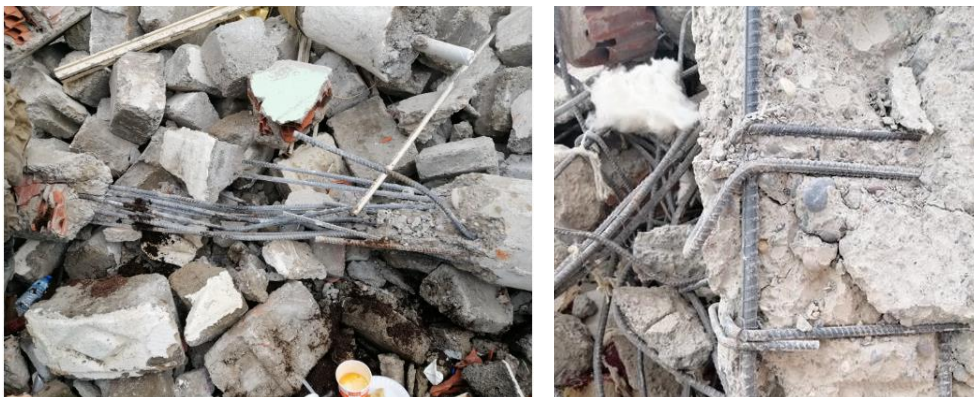
The incorrect placing of the reinforcement bar

Incorrect end hook angle and length

Fig. 16. The workmanship defects

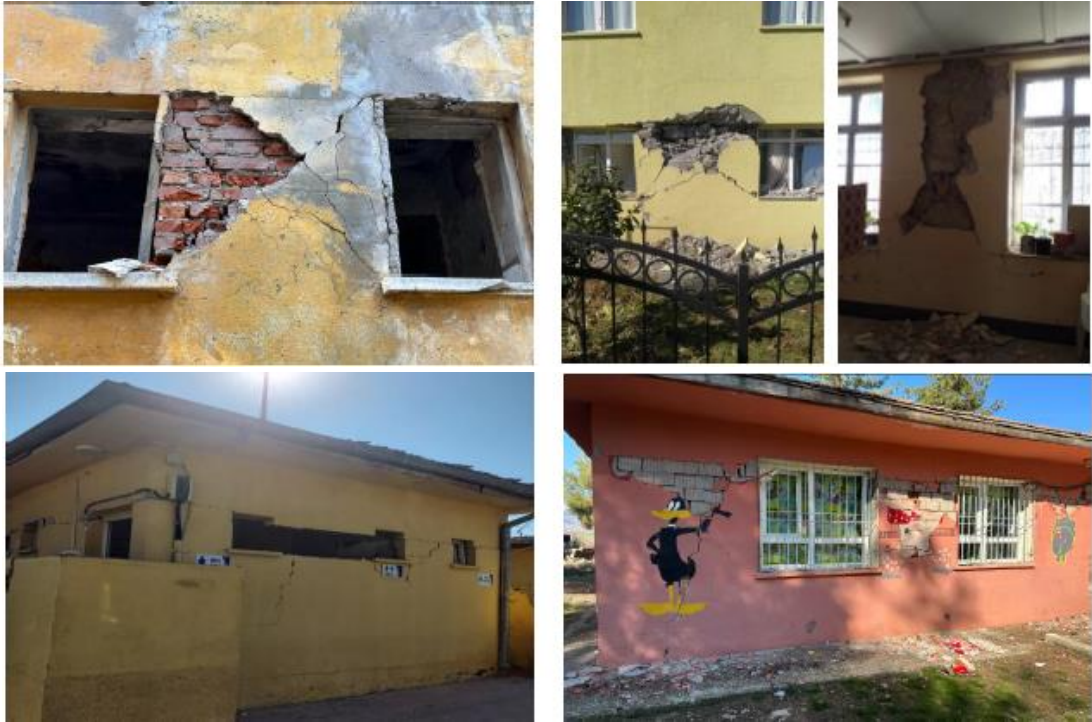
Fig. 17. In-plane damages on masonry buildings

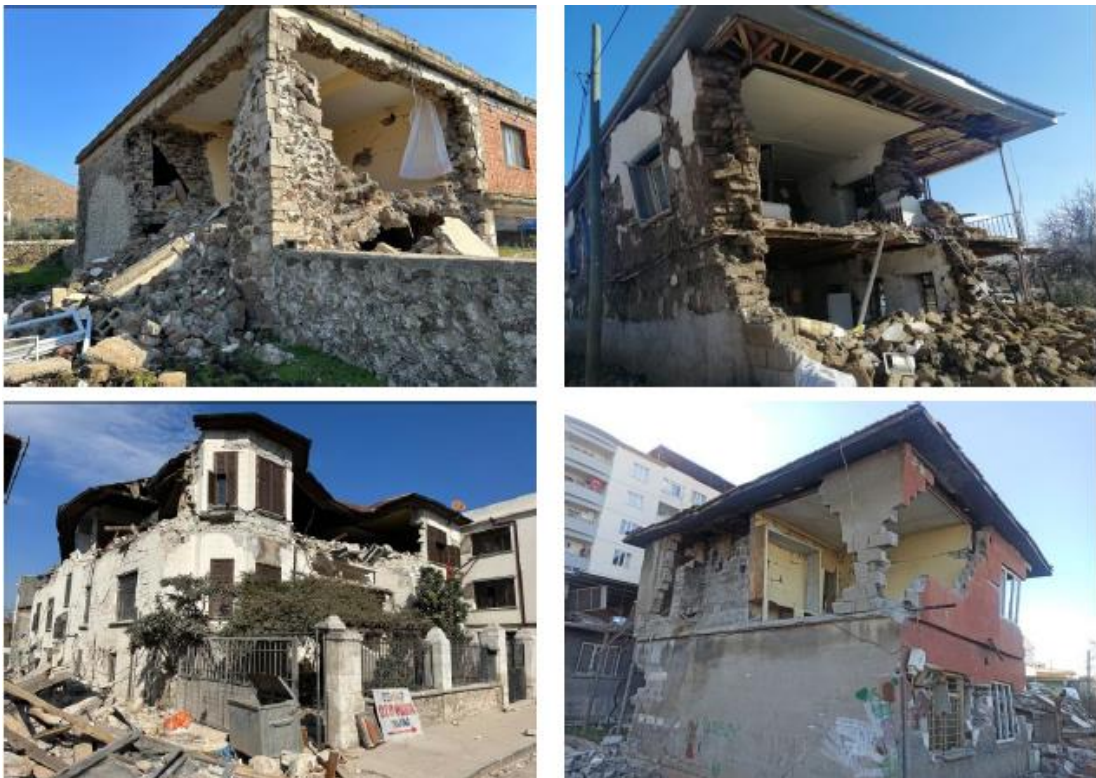
Fig. 18. Out-plane damages on masonry buildings

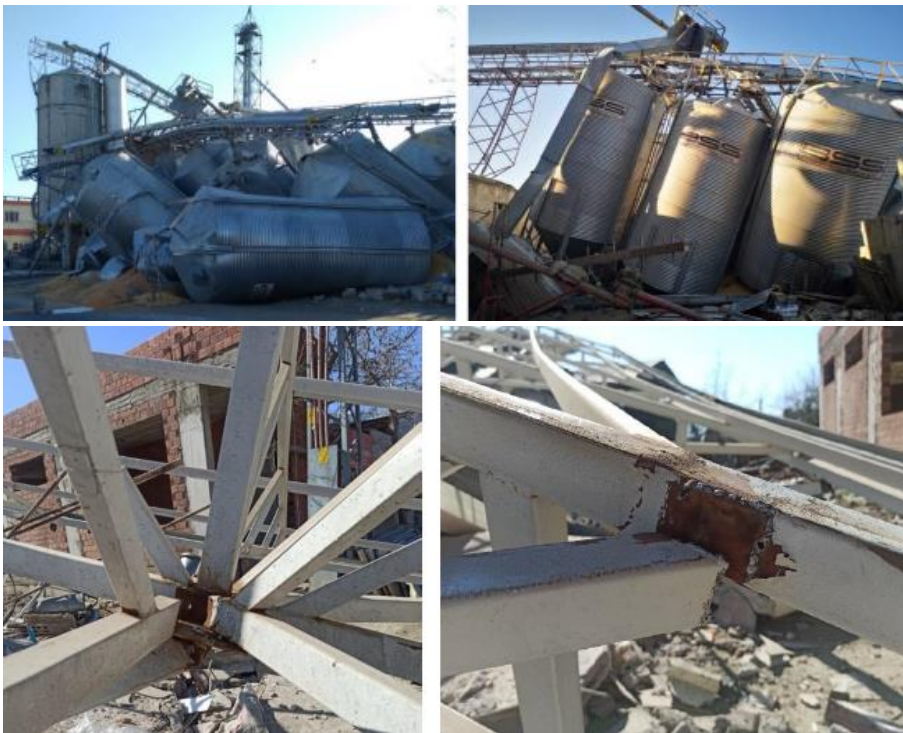
Fig. 19. The damages on steel industrial structures

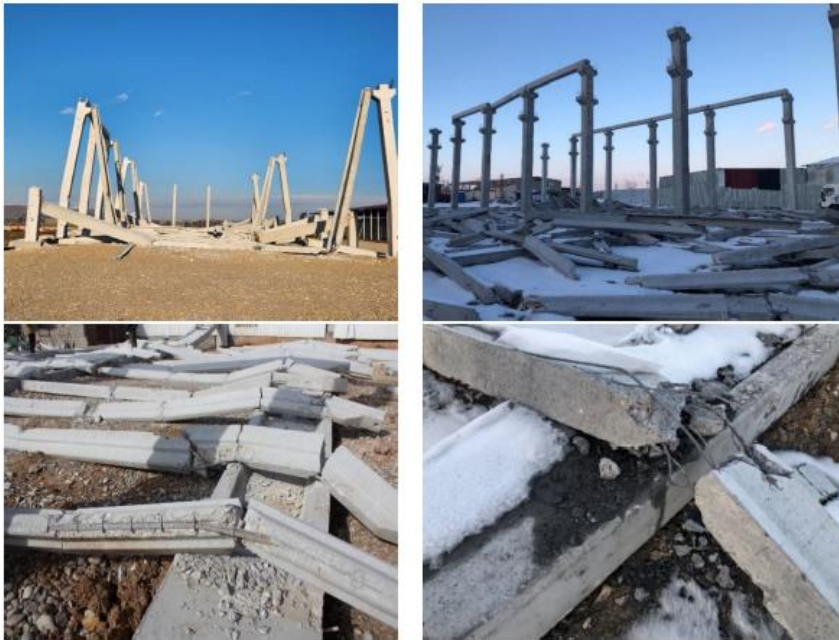
Industrial buildings in the earthquake zone generally consist of prefabricated reinforced concrete systems, a small number of steel carrier systems, and small industrial structures consisting of classical reinforced concrete frame systems. In the field observation, it is seen that the majority of reinforced concrete prefabricated factories have structural damage, and a lower rate of damage occurs in a small number of steel-constructed industrial structures. Steel structures can be damaged in earthquakes due to application and design errors and not receiving adequate engineering services (Fig. 19). In prefabricated industrial structures, load transfer cannot be completed in the system because the columns on the roof are not connected with sufficient rigid elements. They are connected with articulated purlins and a rigid diaphragm is not formed. Roof beams are placed perpendicular to the long direction in industrial buildings and are supported by pin connections to the columns. Similarly, purlin beams are articulated to the roof beams with very weak pins. For these reasons, damages occurred to the roof and purlin beams (Fig. 20).

Fig. 20. The damages on steel industrial structures

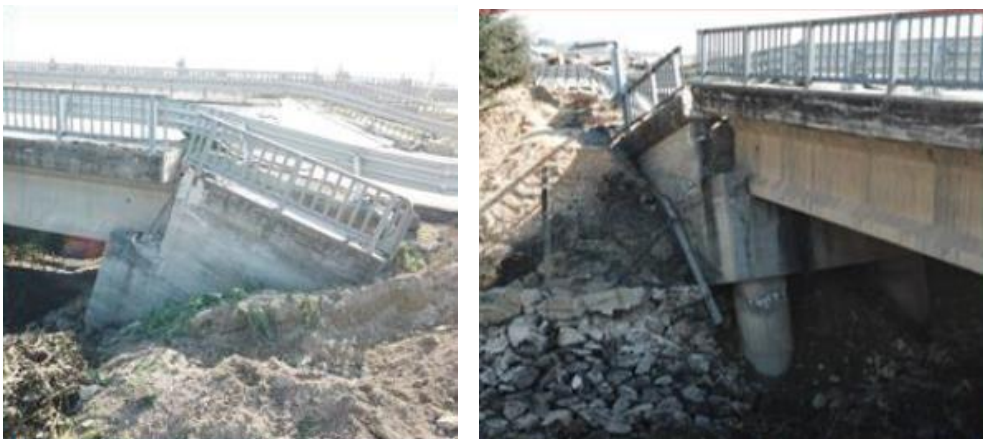
Fig. 21. Ground-foundation damages

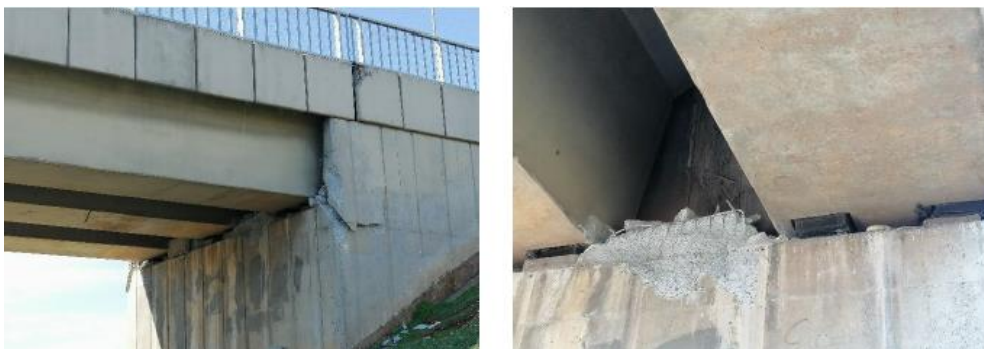
Fig. 22. The joint and support damages

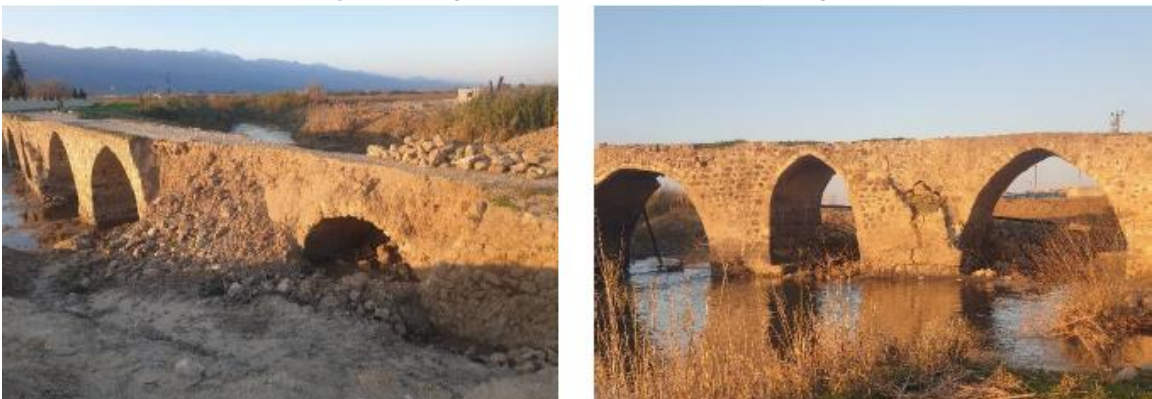
Fig. 24. Observed collapsed and cracks of the spandrel wall

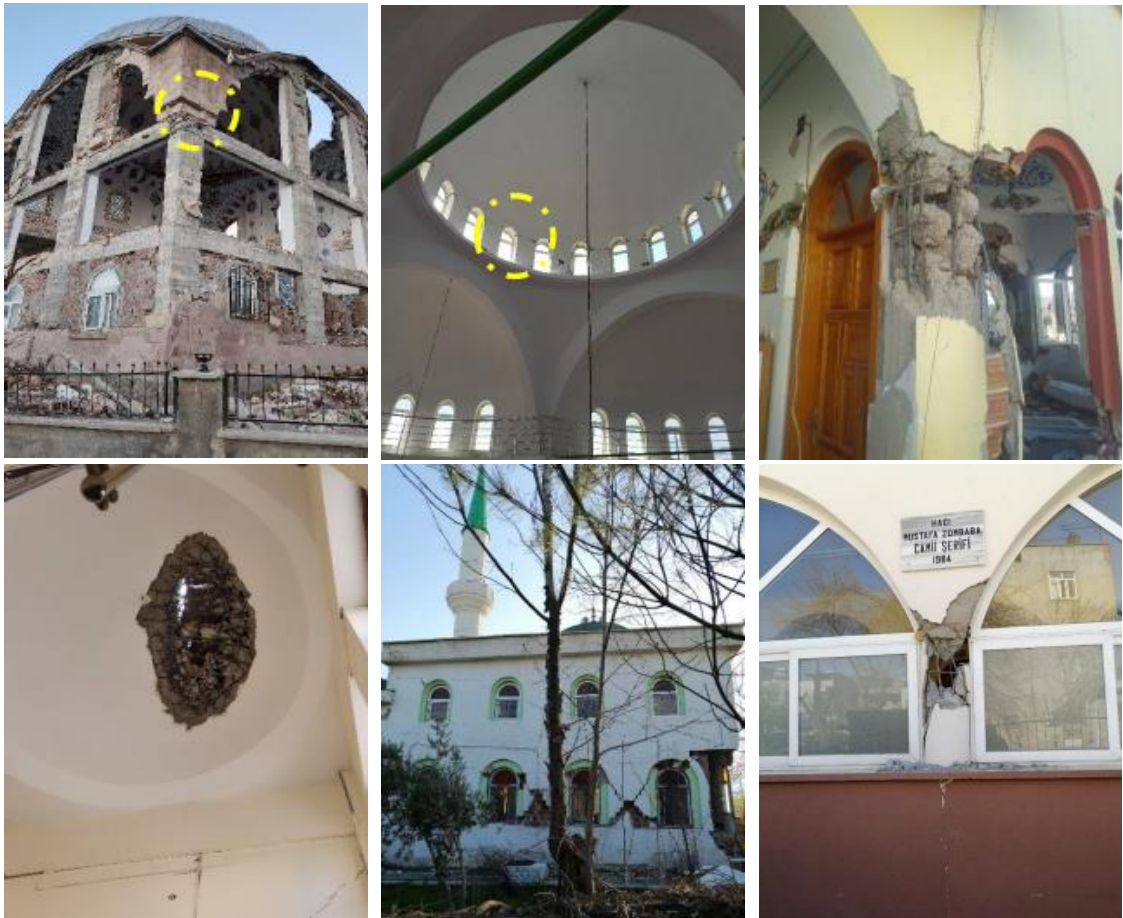
Fig. 25. Observed damages on reinforced concrete mosques

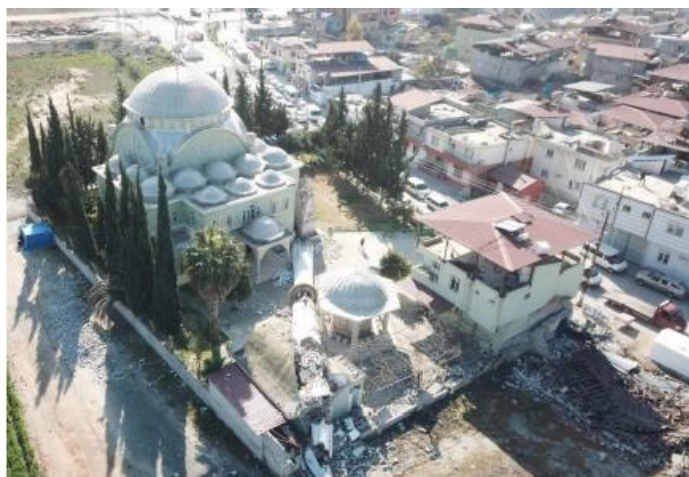
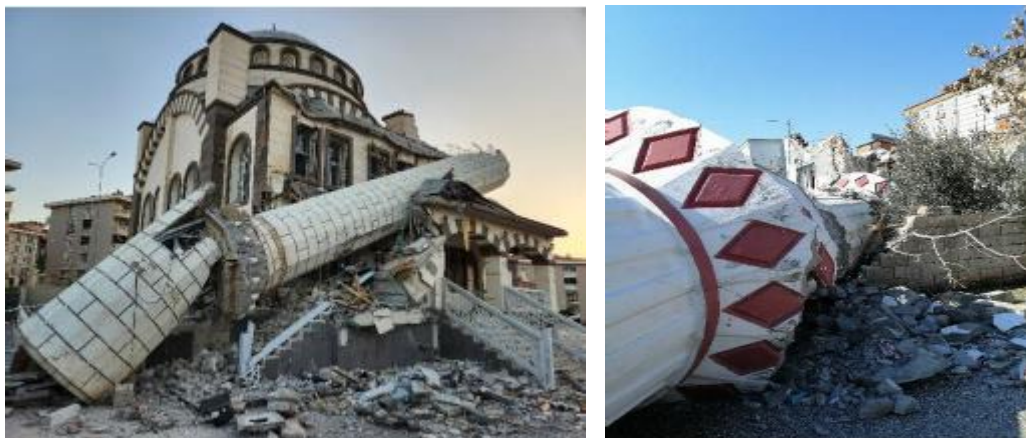
Fig. 27. Observed damages on reinforced concrete minarets

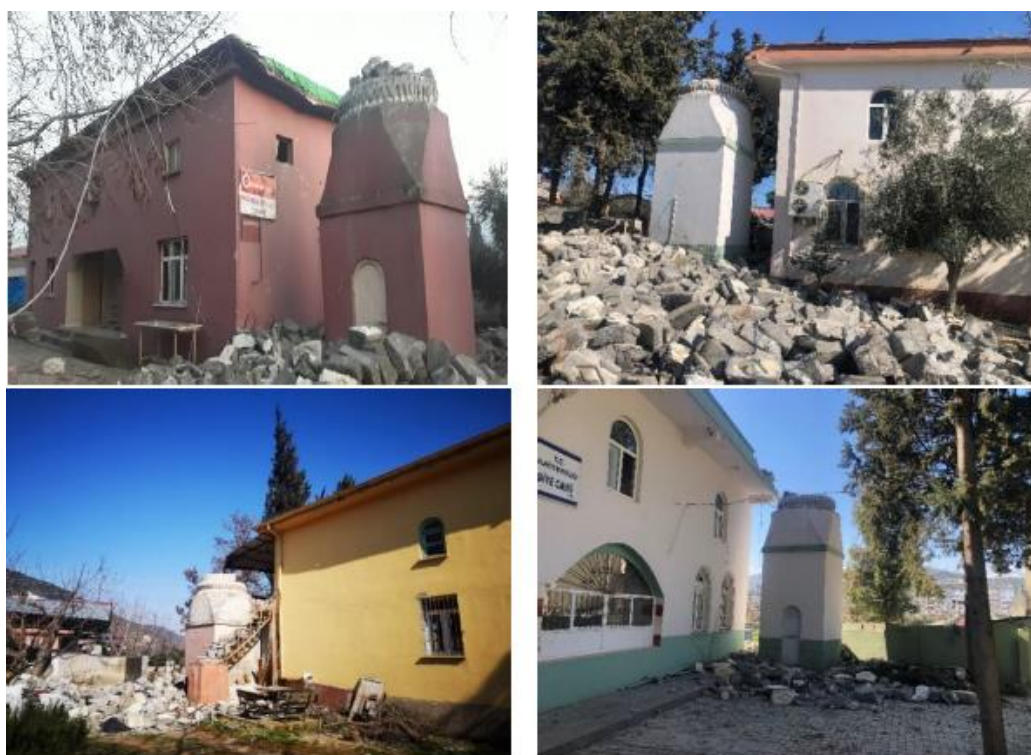
Fig. 28. Observed damages on reinforced masonry minarets
