# Damage mechanisms of masonry structures: an observation after 19 November Erzurum-Köprüköy Earthquake

İrfan Kocaman<sup>1\*</sup>

<sup>1</sup> Erzurum Technical University, Department of Civil Engineering, Erzurum, Türkiye

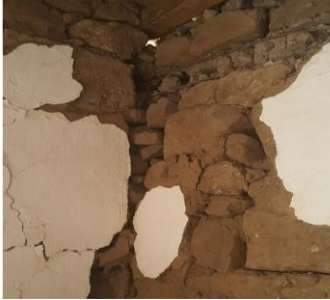
Separation of masonry walls [20]

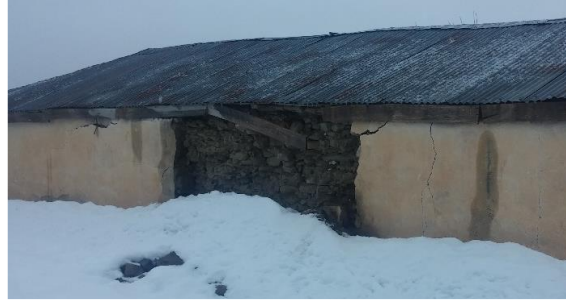
Out-of-plan wall collapse [19]

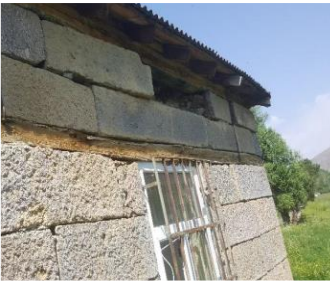
Poor wall-roof connection [20]

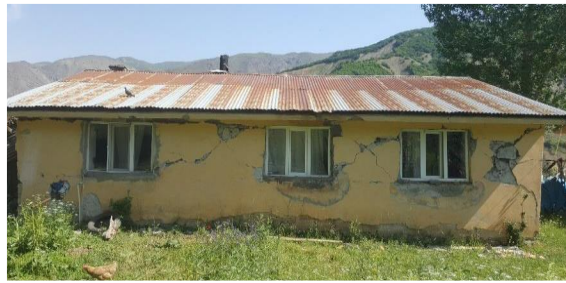
In-plan diagonal cracks [19]

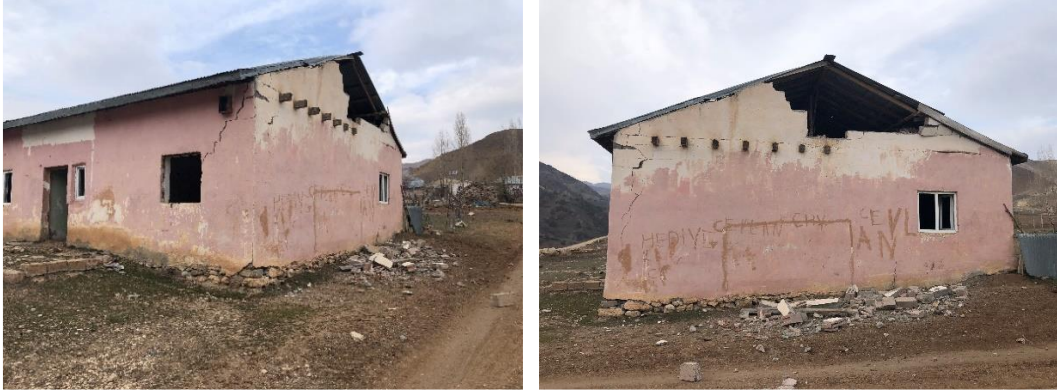
architectural landscape of the region, it becomes apparent that, generally, the roof covering rests upon wooden supports. However, inadequate execution of the junction between stone walls and wooden beams has damaged these areas. Fig.9 depicts a residential building constructed with unused rubble walls. The failure of the retaining wall is evident, accompanied by a diagonal crack originating from the upper corner of a window and extending towards the roof. Despite being unused, the structure has maintained its integrity, but the lack of proper integration between the masonry wall and roof systems has resulted in damage. This example illustrates the recommendation proposed by TBEC-18 [24] and detailed in Fig. 9, where tie beams are suggested for retaining walls.

Fig. 9. Example of damage caused by poor connection between roof and walls

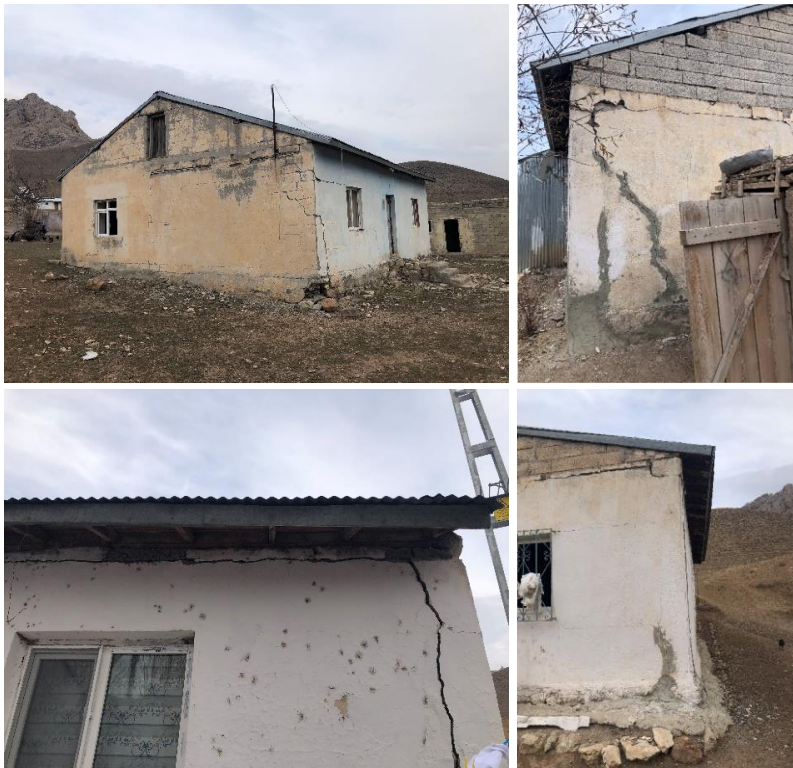
In masonry structures, inadequate connection details between walls can lead to the formation of vertical and diagonal cracks and the separation of walls from each other [11]. Fig. 10 serves as an illustration of this phenomenon. The prevalent typology of rubble walls dominates the landscape of masonry structures within the earthquake-prone region. The junction damages manifest similarly across different structures in various villages. This situation can be attributed to the lack of engineering services during past construction practices and/or prevailing poor workmanship in the region.

Fig. 10. Segregation damages at junction areas

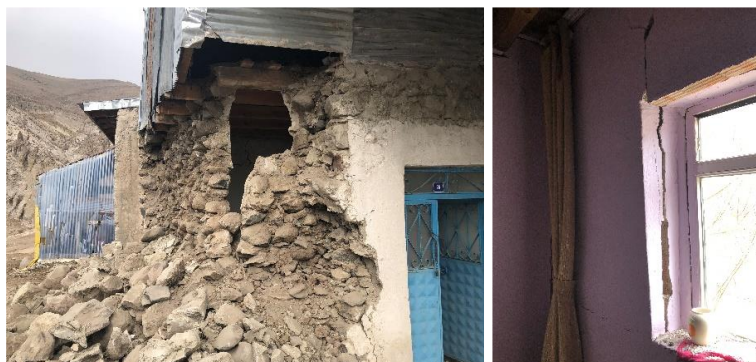
Masonry structures exhibit diverse configurations, with variations encompassing both single-leaf and multi-leaf masonry walls. The proper execution of the junction between this leaf profoundly influences the structural response, particularly concerning out-of-plane resistance a subject examined by Binda et al. [25]. The typology of masonry structures in the region predominantly revolves around the utilization of two-leaf rubble walls. Fig.11 presents observed out-of-plane displacement mechanisms in two different structures. The two leaf in these walls do not work together but separate under the influence of out-of-plane loading. Factors such as the strength of the bonding material used in rubble walls, interlocking arrangement of stones, and proper execution of roof junctions contribute to the improved interaction between leaves.

Fig. 11. Disconnection damage in multi-leaf walls

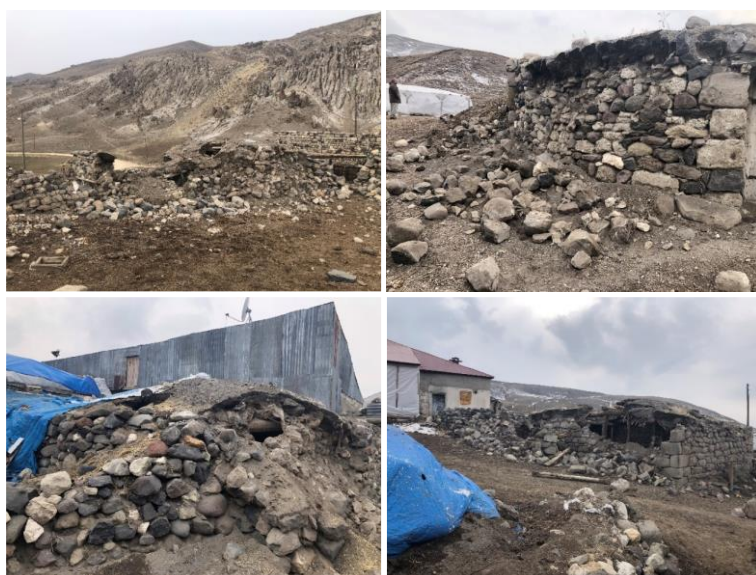
Within the earthquake-affected region, masonry structures typically feature earthen roof coverings, known as thatched roofs. However, in recent years, masonry structures have been replaced by reinforced concrete buildings due to improved economic conditions and urban transformation projects. Fig. 12 depicts examples of completely collapsed structures following the prevalent local architectural style.

Fig. 12. Collapsed masonry structures

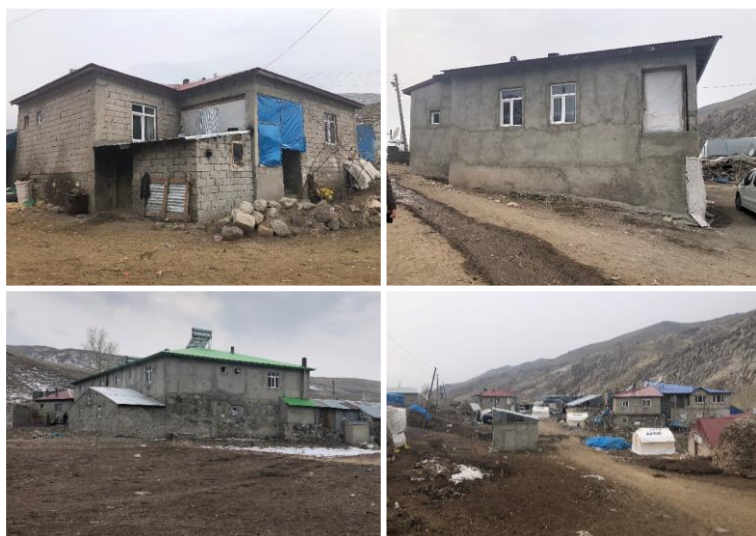
The field observations conducted in the villages revealed the presence of single-story reinforced concrete buildings, as depicted in Fig. 13. Remarkably, these structures were found to be free from any discernible damage. It was observed that there is a noticeable shift in the building stock from masonry structures towards single-story reinforced concrete, indicating an abundance in the number of the latter.

Fig. 13. Undamaged reinforced concrete structures
