# Evaluation of the load-bearing wall design of Edirne Old Harbiye Barracks according to the Turkish Building Earthquake Code (TBEC-2018)

Şule Yılmaz Erten<sup>1\*</sup>

<sup>1</sup> Trakya University, Faculty of Architecture, Edirne, Türkiye

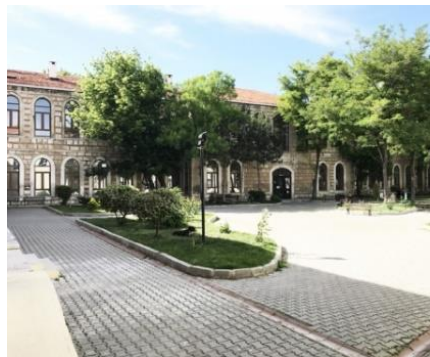
Fig. 3. View from the Courtyard

The building was built on an area of 23.957.50 m<sup>2</sup>, close to the square (Fig. 3). It consists of a basement, ground floor, first floor, and roof. The rectangular building (Fig. 4) around the inner courtyard extends in the south-north direction. This building was created by combining the "Harbiye Building", which is given as block B in Fig. 5 with an "L" plan, covering the north and west wings of the inner courtyard, and the rectangular planned block A that covers the east wing of the courtyard, from the north and south corners. It was formed as a result of combining the rectangular planned block C, which was built as an additional service building on the east and parallel of this building, from the north and south corners during the Republic period (Fig. 5). In some of these joint parts, there are dilatations because they were made at different times. The short side length of the building is approximately 73 m, and the short side length is approximately 84 m.
