# Damage assessment of a cement plant partially collapsed depending on various causes

This study aims at examining the possible causes of the brittle collapse of a tertiary air duct system under vertical loads. Problems related to the design and construction stages were examined. The entire process was illustrated using a tertiary air duct case study in a cement plant. In the plant, the tertiary air duct collapsed without any earthquake, blast, or impact effects. The current study includes a field study, examination of an original/revised design project, and numerical simulation. In the first stage of the study, the existing state of the collapsed system and its compliance with static and mechanical projects were examined. Secondly, a two-dimensional finite element analysis was performed to determine project eligibility. The causes of the system were determined based on the data obtained in the former stages. The results showed that the causes of partial collapse included project errors, construction faults, and project incompatibilities.

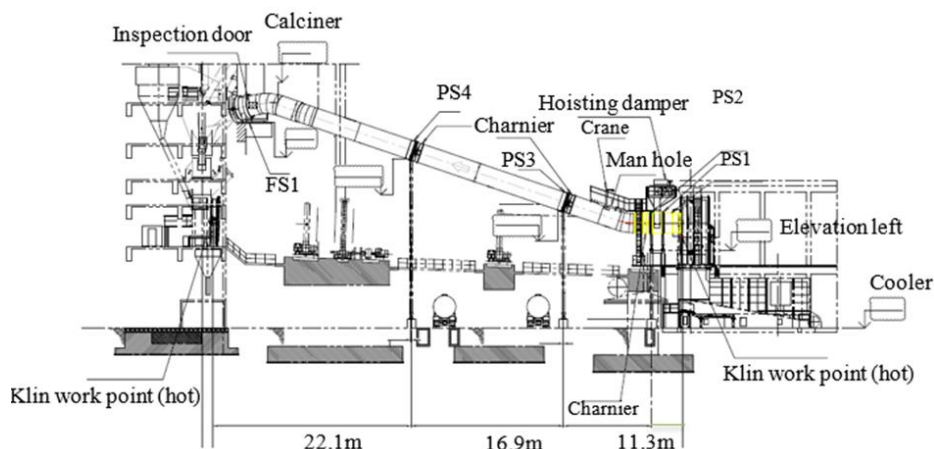
The examined plant was established in the 1950s. Later on, since the clinker line had completed its service life, it was replaced by a rotary furnace with a dry system. After the improvements were made to the rotary furnace unit, the furnace capacity was increased [11]. In 2018, the production capacity was increased with the modernization of the cooling tower and tertiary air duct (Fig. 2). Just two months after this modernization, the tertiary air duct collapsed.

Fig. 2. Elevation view of the cement plant

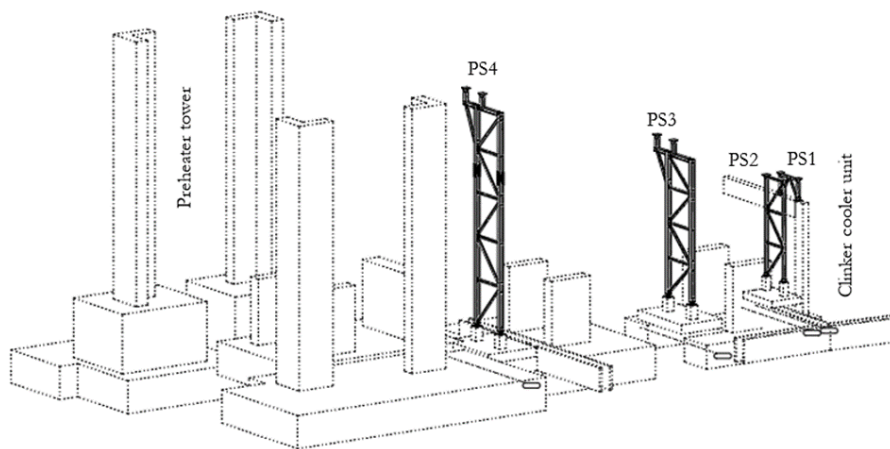
**Fig. 4.** An isometric view of the tertiary air duct (The duct indicated by A in Fig. 3) was placed on the columns PS1, PS2, PS3, and PS4)

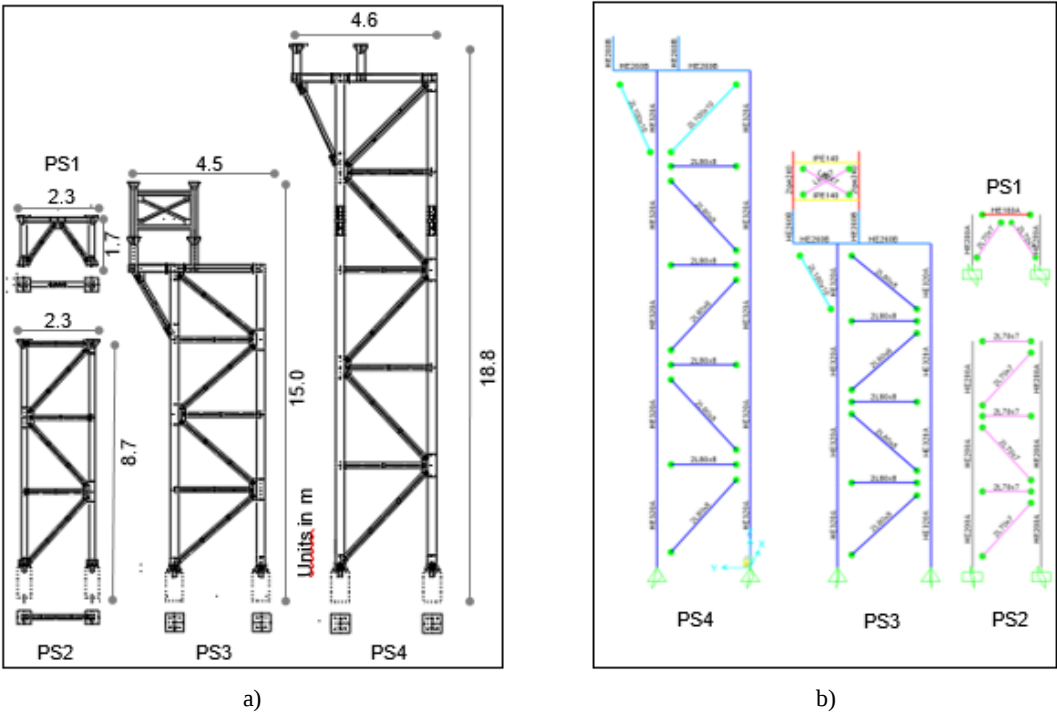
Fig. 7. (a) The planar truss system, (b) Structural models

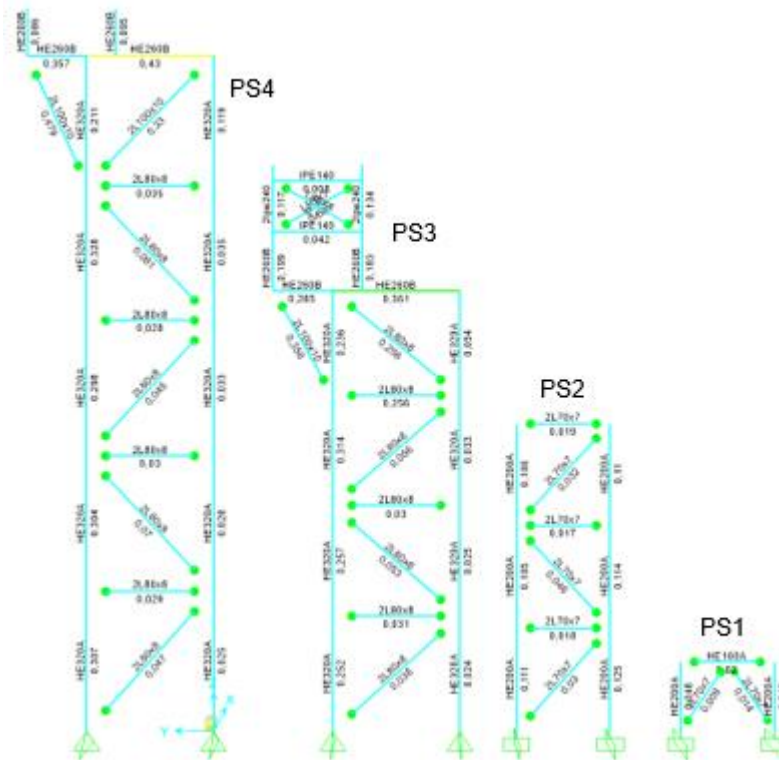
Fig. 20. Analysis results for vertical loading
