RESEARCH ARTICLE

# Repair of buckled steel braces via buckling zone relocation method

In this study a new repair method, called buckling zone relocation, for buckled steel braces is presented. In this method, buckled zone of the steel brace is wrapped with steel plates to relocate the buckling zone toward the undamaged locations of the brace. Thus, the brace can be reach buckling load again. The effectiveness of the proposed method was experimentally investigated. To do this, 2 tubular brace specimens, each have 2000 mm length and 70×70×3 mm cross section, were subjected to quasi-static cyclic loadings. First specimen were loaded until global buckling and then unloaded to repair with the proposed method. The length of the buckling zone to be repaired with steel plates was determined with finite element analysis. When the repair process completed, the specimen reloaded until collapse. The second specimen was loaded until collapse to be used as reference member. As a result, it was determined that the buckled steel brace tested in this study could been effectively repaired via buckling zone relocation method without any significant decrease in its performance.

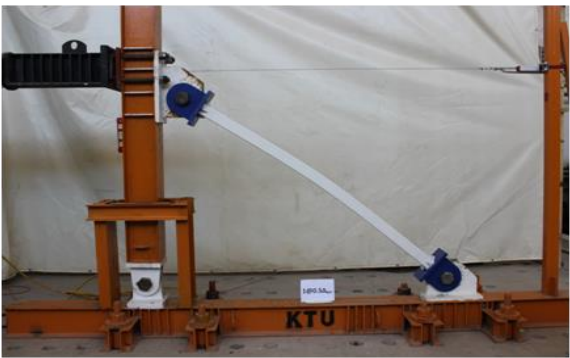
Fig. 4. The cyclic behavior of the C1 specimen until buckling

In the first stage, the C1 specimen was tested under cyclic load until buckling. C1 specimen showed elastic behavior during the first displacement step. In the second displacement step, the specimen loaded until buckling and the maximum compression load of 165.57 kN was reached at a horizontal displacement of 4.48 mm. In the first cycle of the third displacement step, buckling occurred at a displacement of 4.58 mm and a load level of 158.97 kN (Fig. 4). Immediately after the buckling, there was a sudden decrease in the load. After this stage, the hydraulic actuator unloaded to the zero position and the repair stage was started.

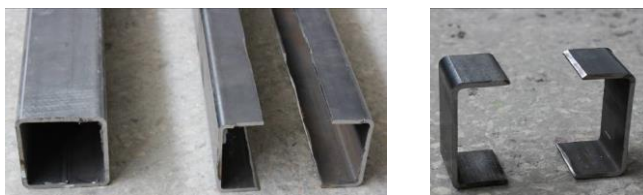
Fig. 6. Wrapping plates

600 mm and a cross section of  $80 \times 80 \times 4$  mm was cut in half to be used as a wrapping plate (Fig. 6). The region of plastic deformation was repaired by wrapping these plates and C1\_R element was obtained. In the repair process, first of all, 600 mm long wrapping plates (red) were placed on the test specimen to cover the damaged area. Then they were welded to the C1 specimen at their free ends. In order to remove the local buckling from the welded ends of the wrapping plates in the cyclic loading to be applied, additional 50 mm long wrapping plates (green) were welded to the repaired area from both ends. The other ends of the additional wrapping plates left free (Fig. 7).
